Climate robustness of wooden roofs

Lars Gullbrekken
PhD-kandidat

MÅL

Få oversikt over typiske byggskader og nedbrytingsmekanismer for skrå tak

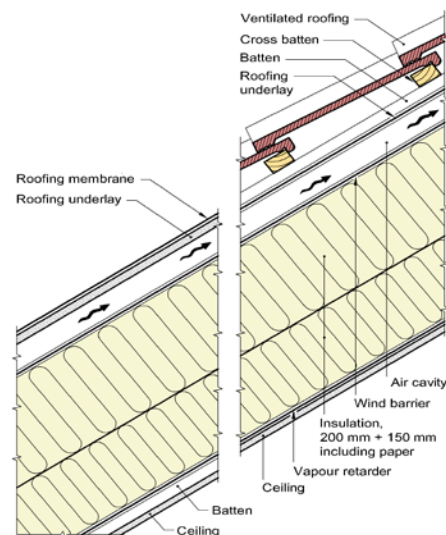
Type A: Isolert skrått tretak med lufting mellom undertak og vindsperre

- Type A: Isolert skrått tretak med lufting mellom undertak og vindsperre
 - Fukt fra innvendig luft og utvendig nedbør er typiske skadeårsaker
 - Flere fuktskader fra innendørs fukt sammenlignet med Type B.

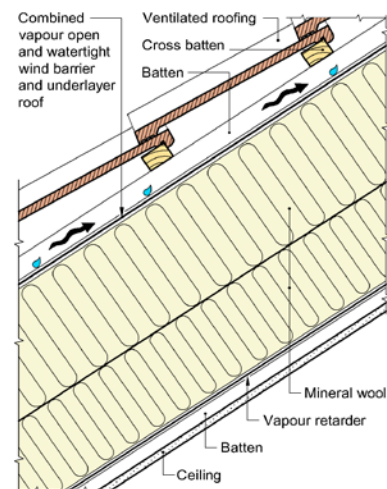
Type B: Isolert skrått tretak med kombinert undertak og vindsperre

- Type B: Isolert skrått tretak med kombinert undertak og vindsperre
 - Nedbør mer hyppig skadeårsak sammenlignet med Type A.
 - Tsjekkiske og Danske feltundersøkelser av kombinerte vindsperrer og undertak viste dårlig vanntetthet.

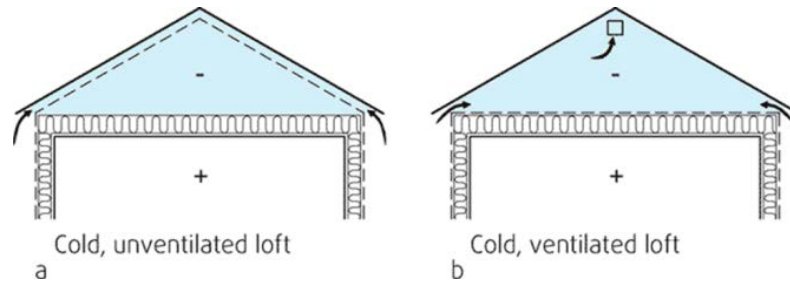
Type C: Tretak med kaldt loft

- Type C: Tretak med kaldt loft
 - Luftet løsning er sårbar for luftlekkasjer gjennom dampspærren.
 - Like mange skader som Type A og Type B til sammen.

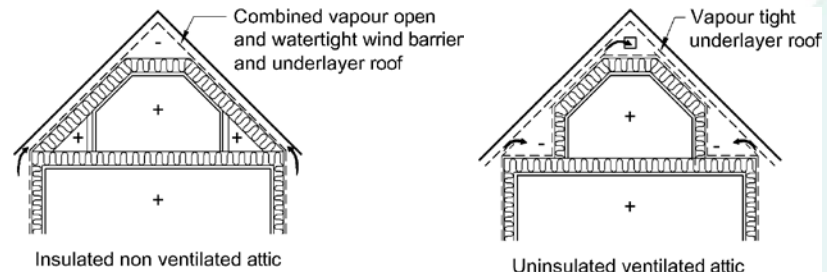
Type D: Tretak med oppvarmede rom i deler av loftet

Fig.4. Roof Type D with living rooms in part of the attic. Thermally insulated non-ventilated attic rooms (left) and thermally non-insulated, ventilated attic rooms (right)[16]

- Type D: Tretak med oppvarmede rom i deler av loftet
 - Utførelse av kontinuerlig innvendig sperresjikt er utfordrende.
 - Like mange skader som type C.

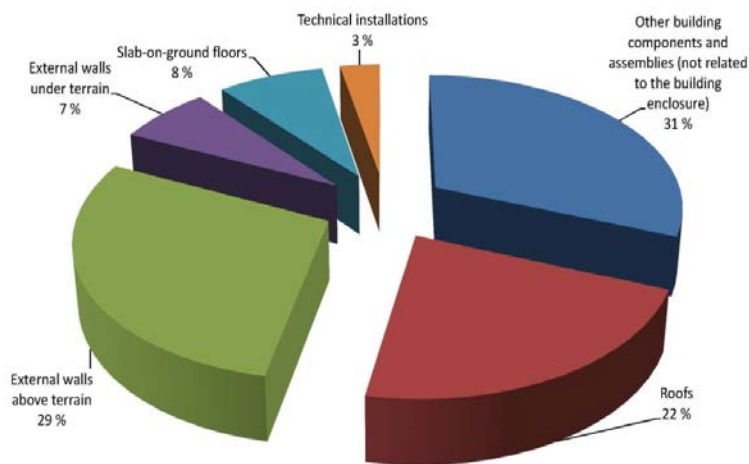
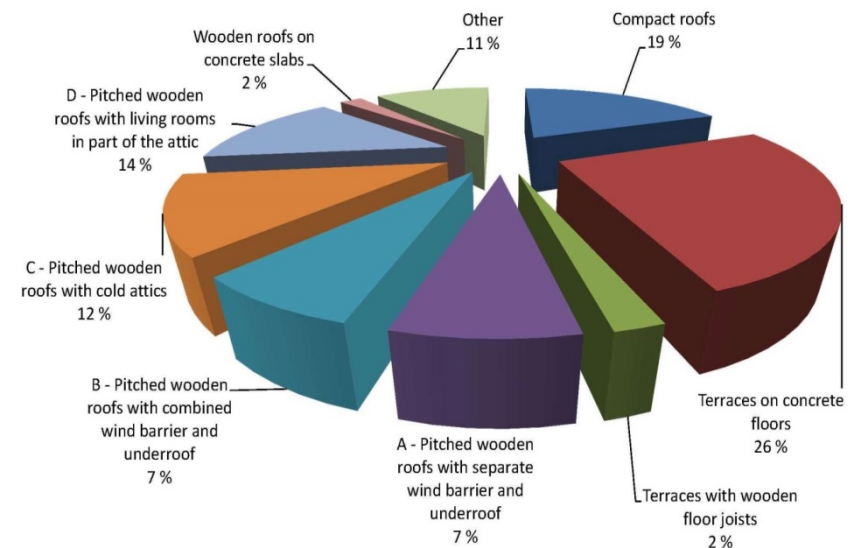
Analyse av SINTEF Byggforsk byggskadearkiv

Vi har studert perioden 1993-2002 inkludert 2003 rapporter og 2423 byggskader.

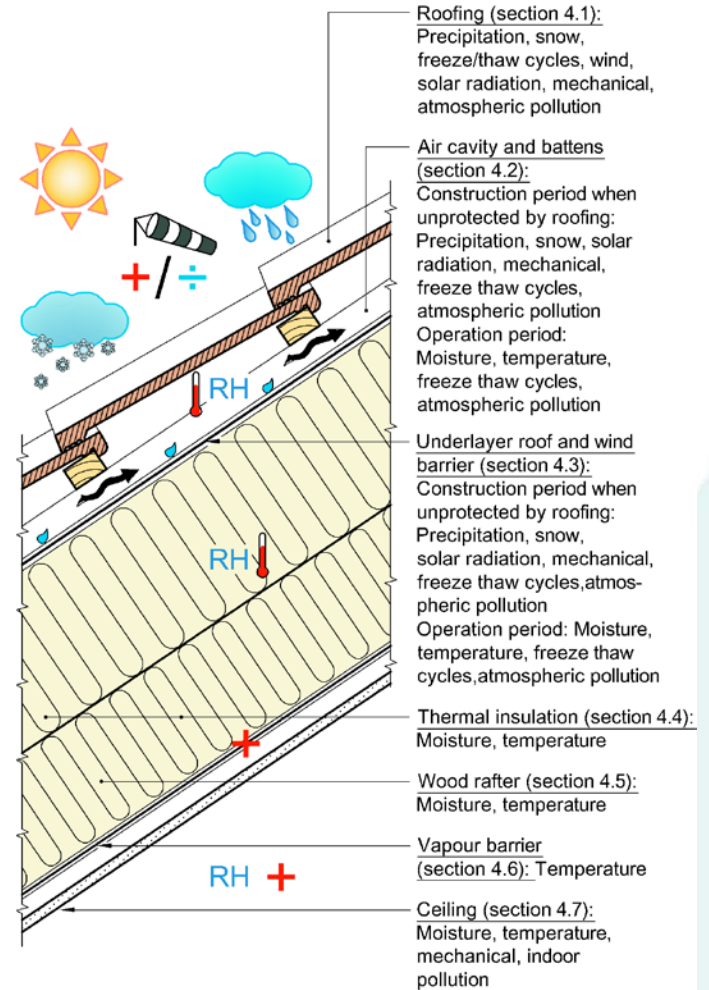
Air and moisture leakage or condensation at roof window

Air leakage through vapour barrier

Lack of proper cavity ventilation above wood rafter insulations

Condensation due to construction defects or inappropriate material selection

Condensation due to air leakages through the vapour barrier

Exterior air leakage from ventilated attics

Snow drift at eaves resulting from air cavity design failures

Air and water leakage located at flashings and roof joints/penetrations

Water leakage through the roofing joints

Roofing damage

Damaged or incorrectly installed gutters

Snow melting on roof and icing at eaves because of insufficient ventilation and thermal insulation
