MUSLOC 2019, UPC

Landslide activity in Norway due to intense rainfall and snow melt

*Håkon Heyerdahl, José Cepeda, Bjørn
Kalsnes, Kjersti Gislås, Øyvind Høydal,
Frode Sandersen
(NGI / Klima 2050)*

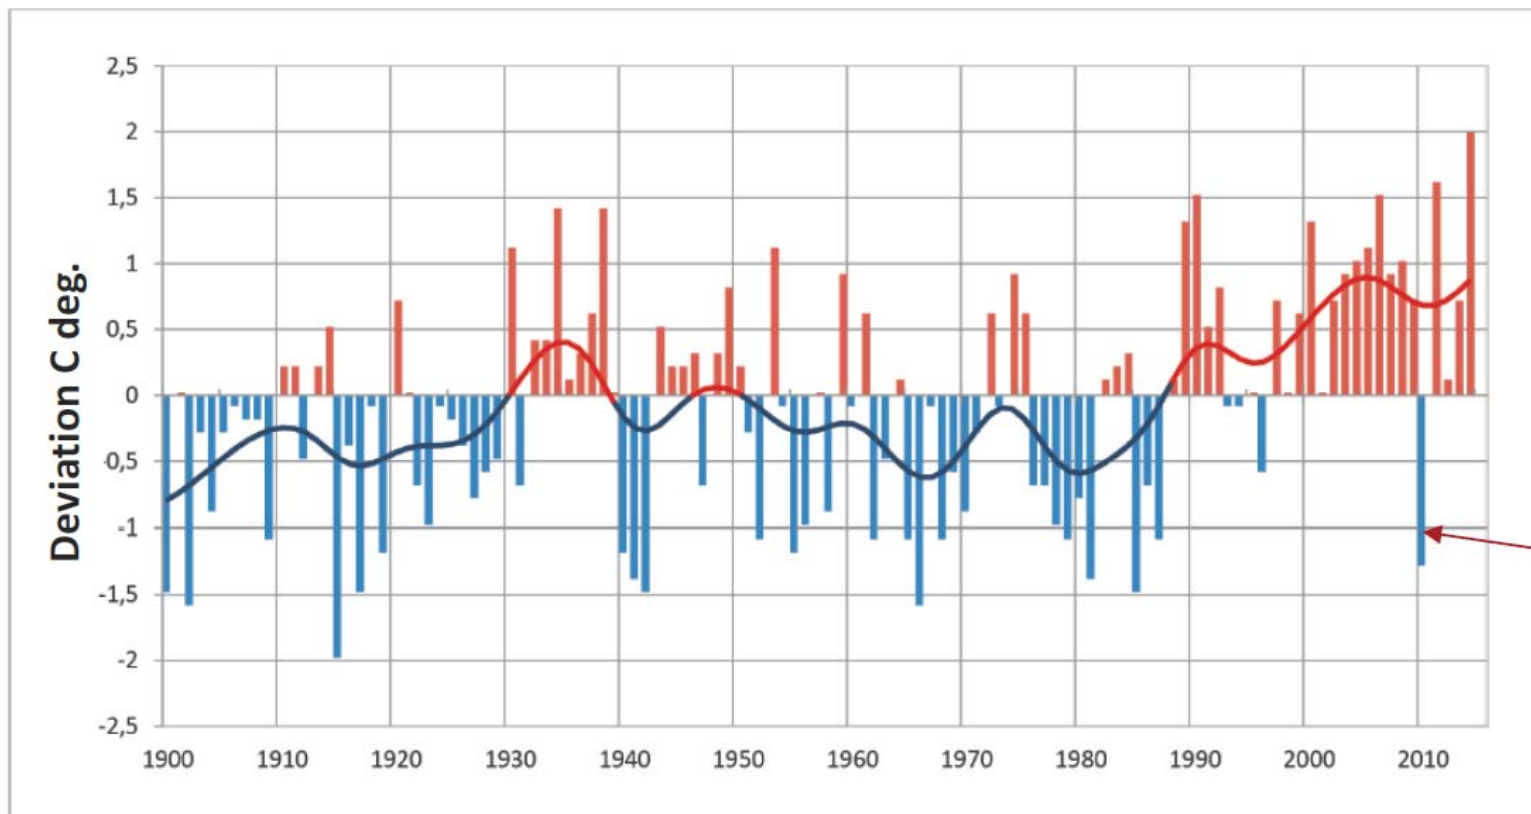
Norway: Development of annual mean temperature 1900-2014

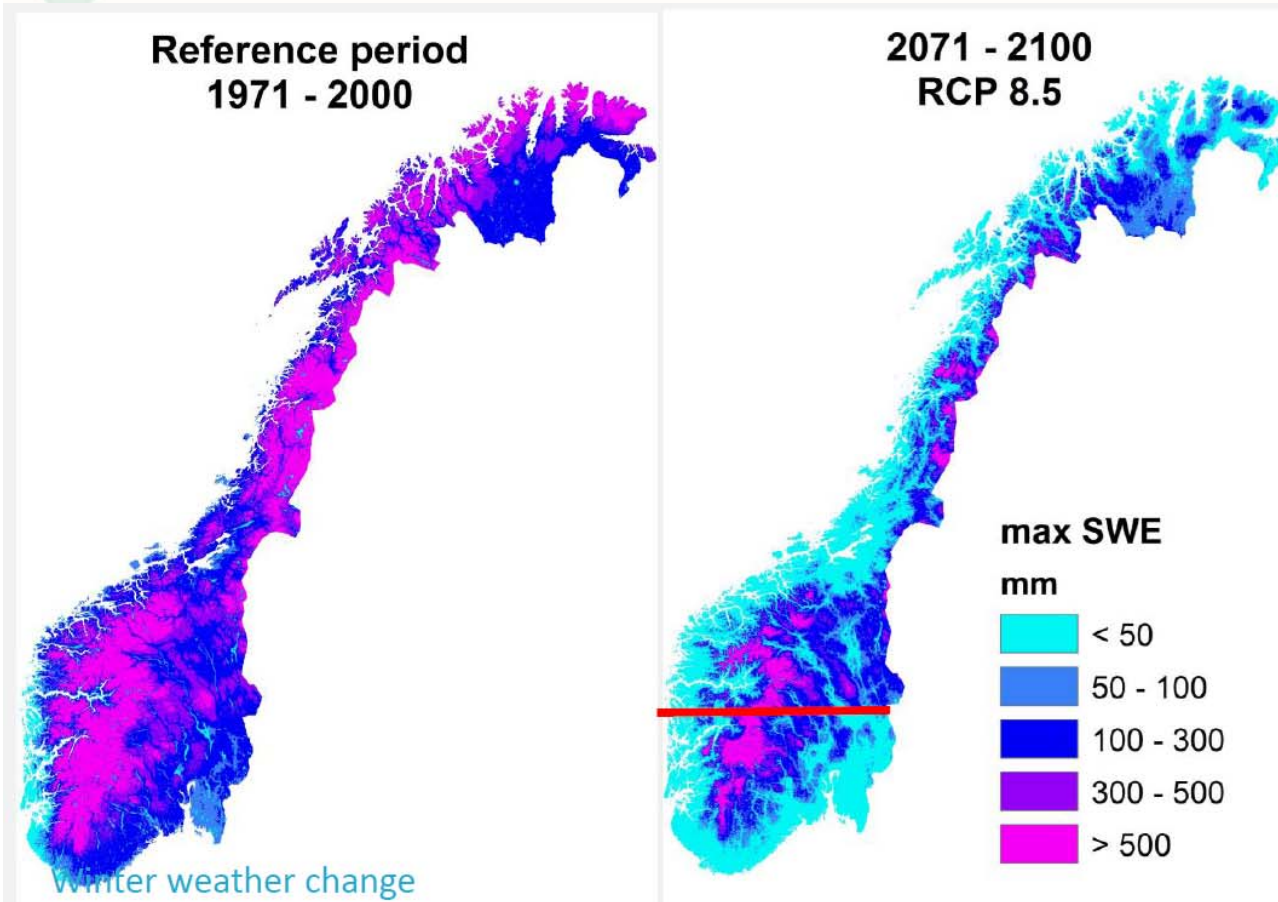
Reduced max snow amount

In high mountain:
Increased precip.,
while most areas will
have an reduction.

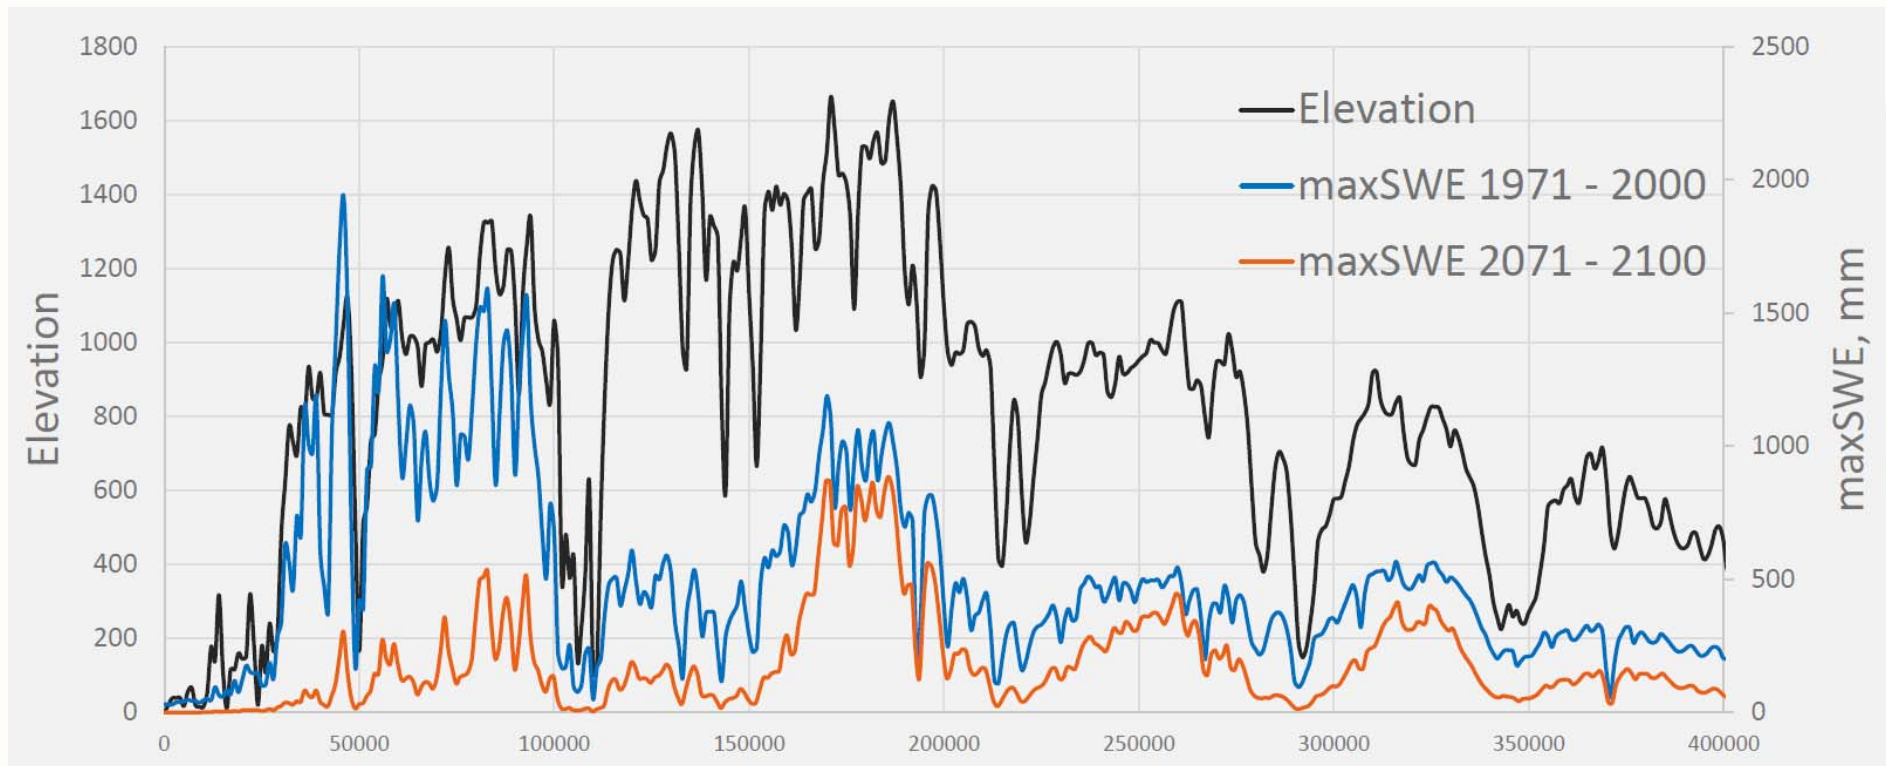
Large reduction in maximum snow amount due to warmer climate

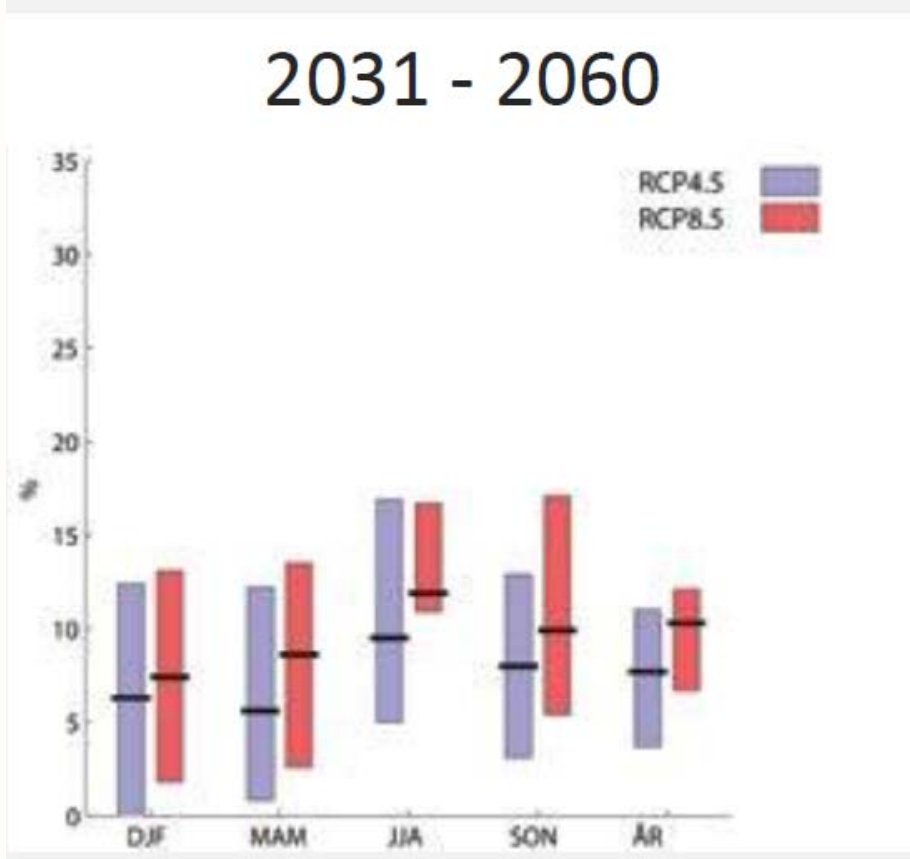
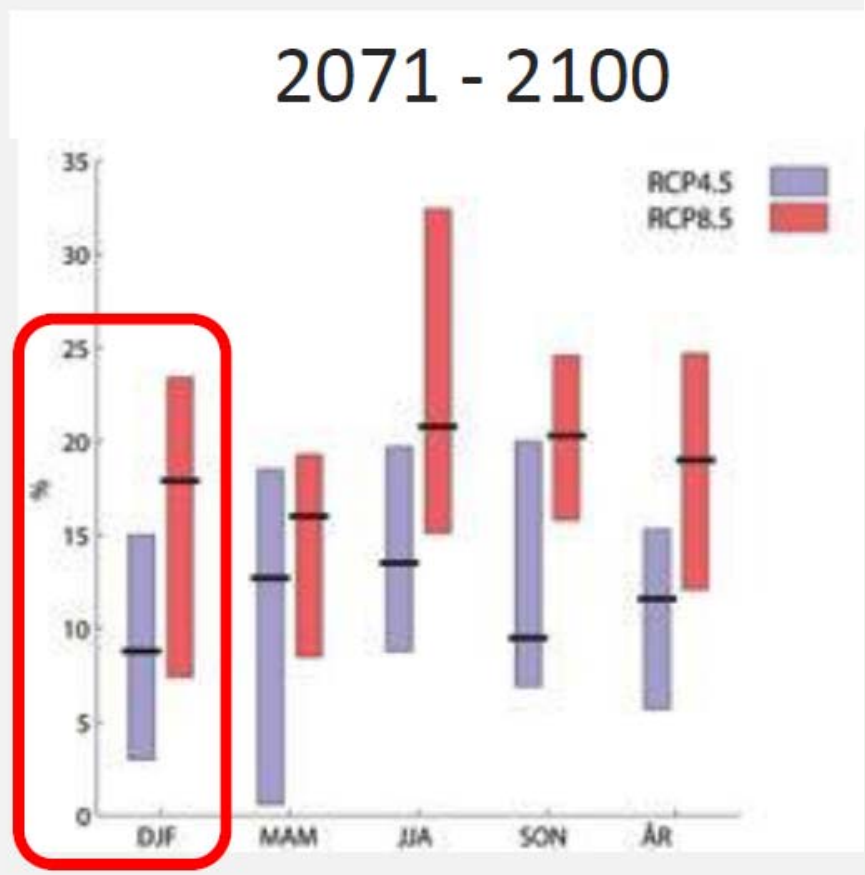
Heavy rainfall: Relative change in precipitation intensity

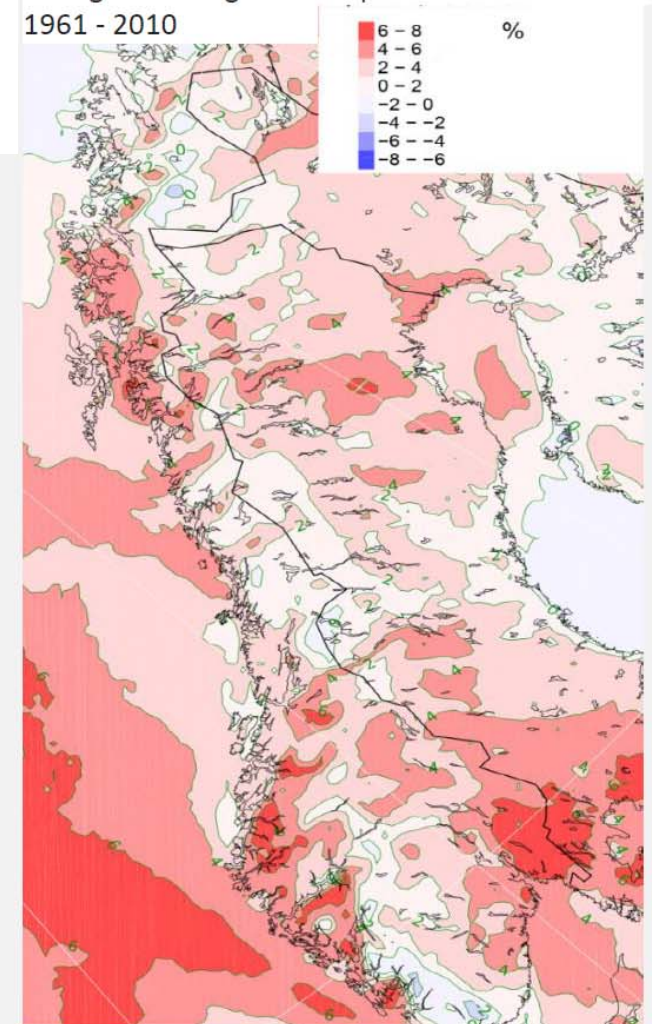
- 1961 – 2010: The strongest wind have increased 6-8% on the west coast
- Future: likely increase in strong wind during winter, but high uncertainty

Change in strong wind 99-percentile linear trend
1961 - 2010

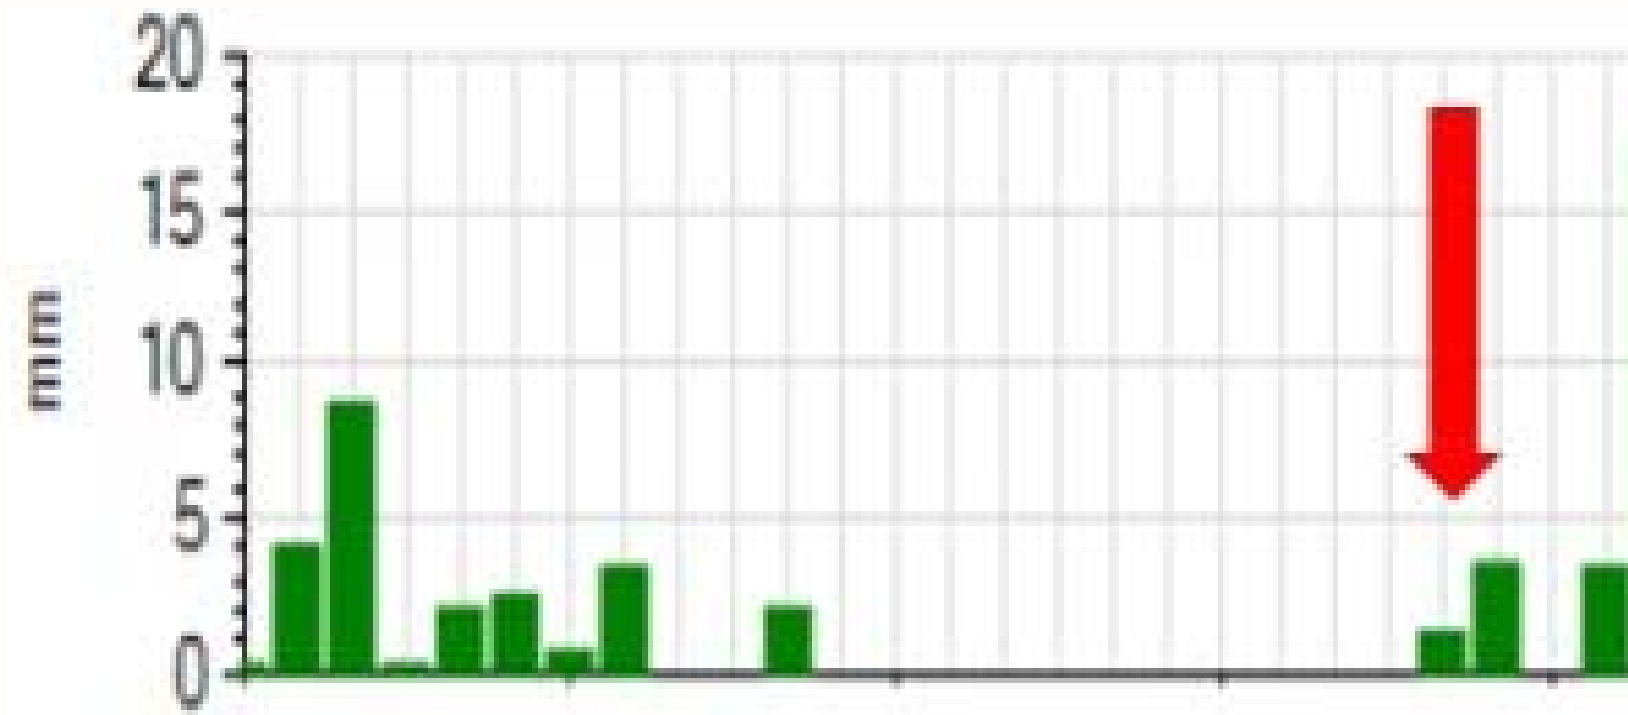
Rainfall before landslide

On the day of the landslide: No rainfall, no snow in the area, sunshine.....

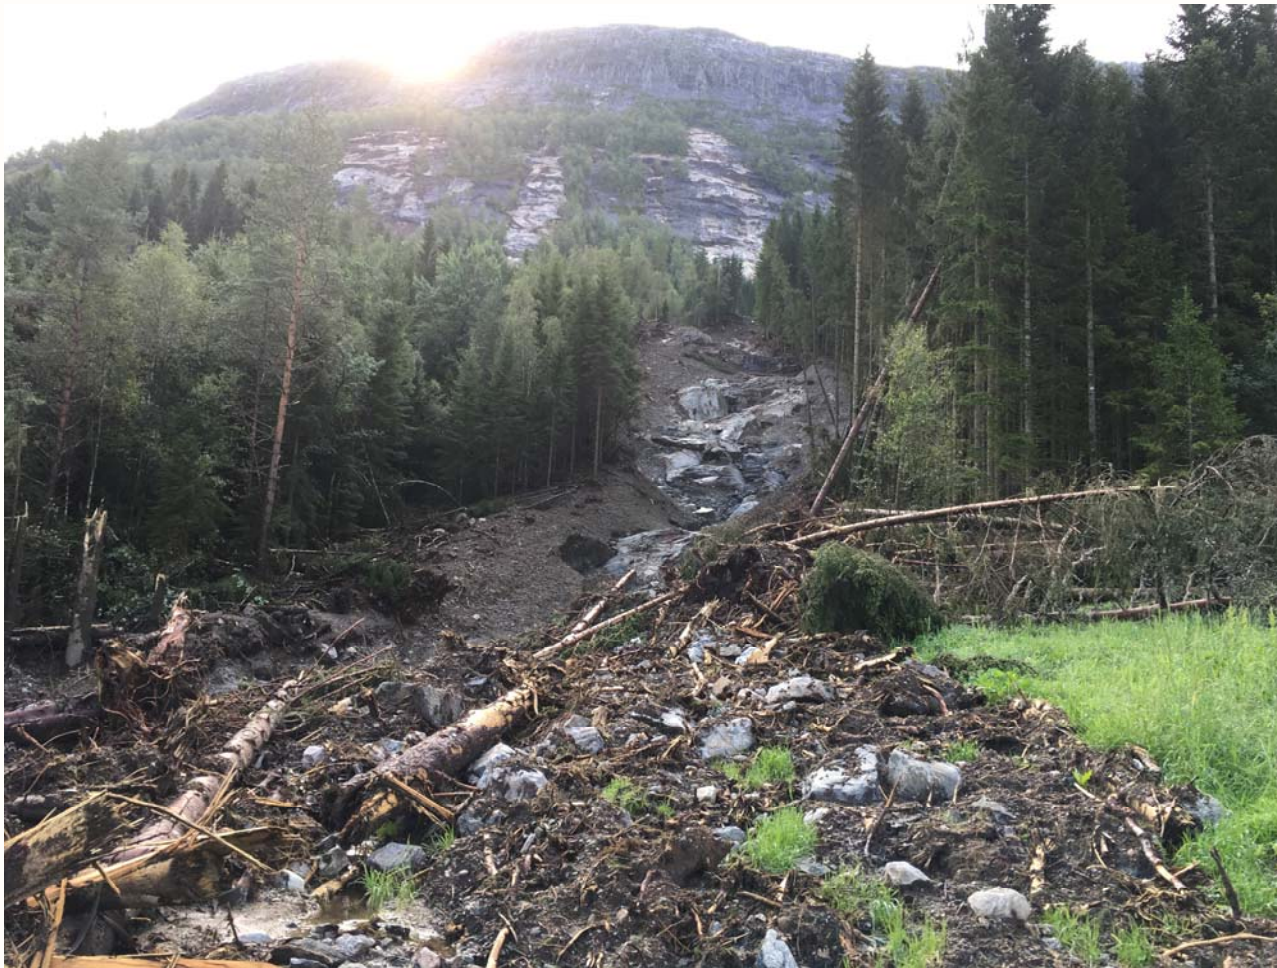
Jølster, 2019 – Debris flows scraping off soil to bedrock

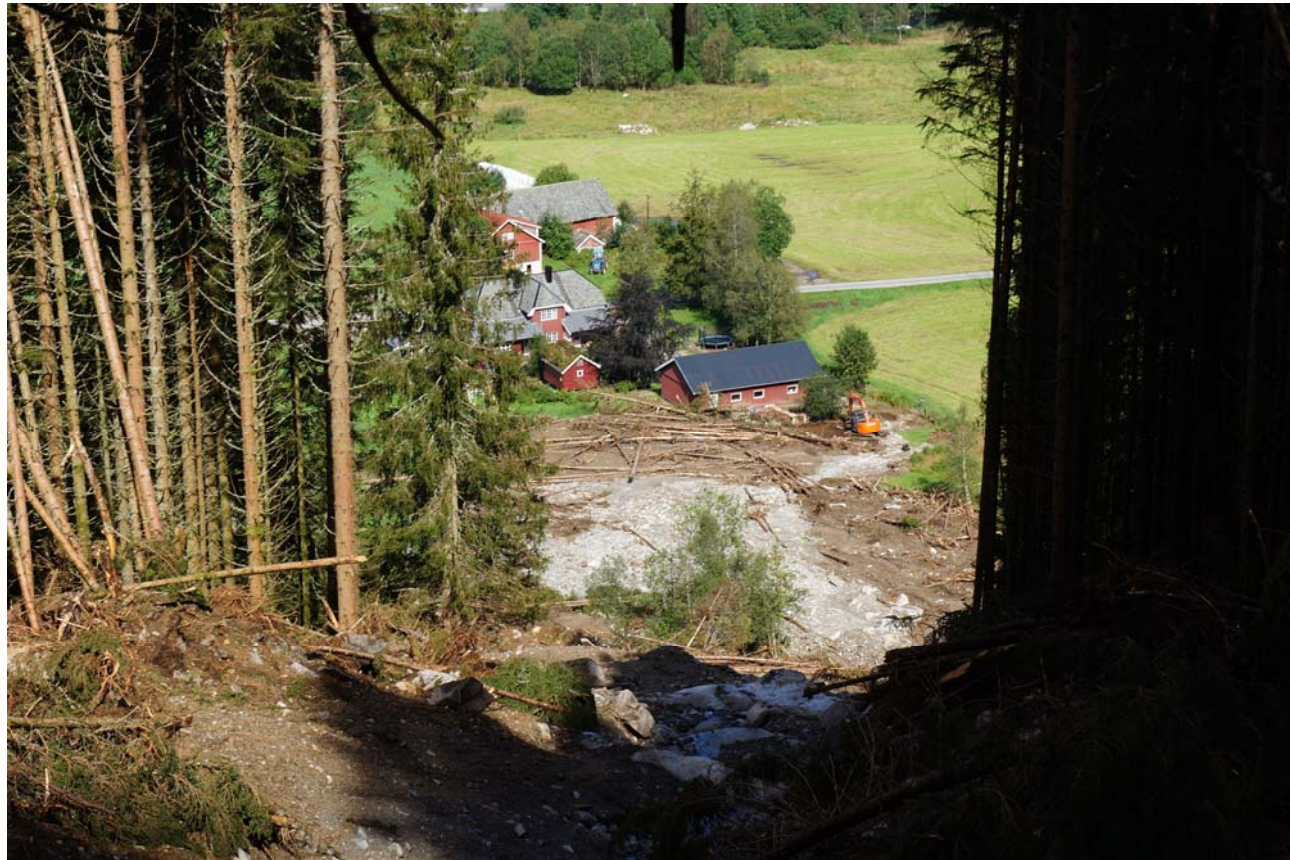
Jølster, 2019 – Runout towards farm

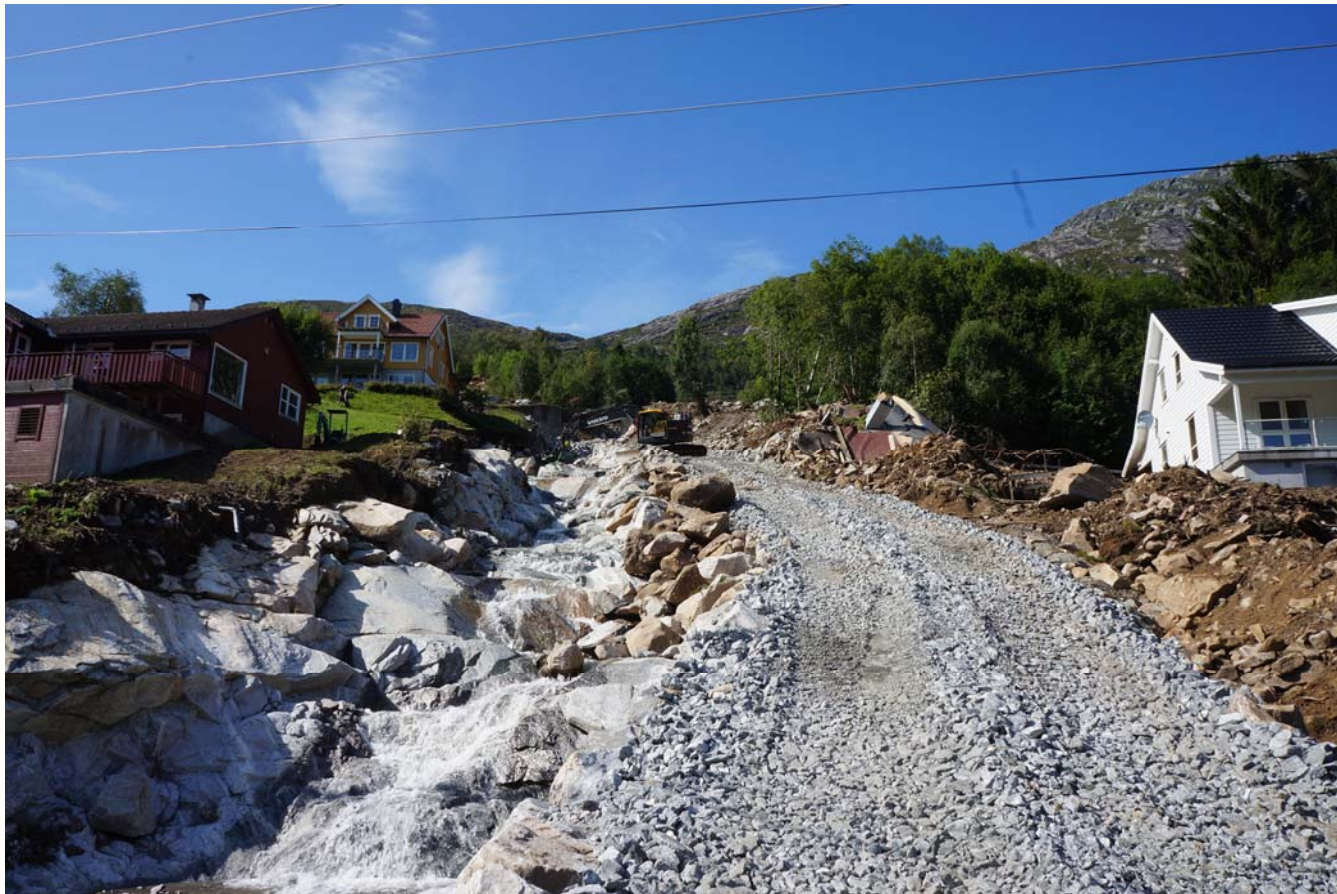
➔ Jølster, 2019 – Vassenden, debris flow along river

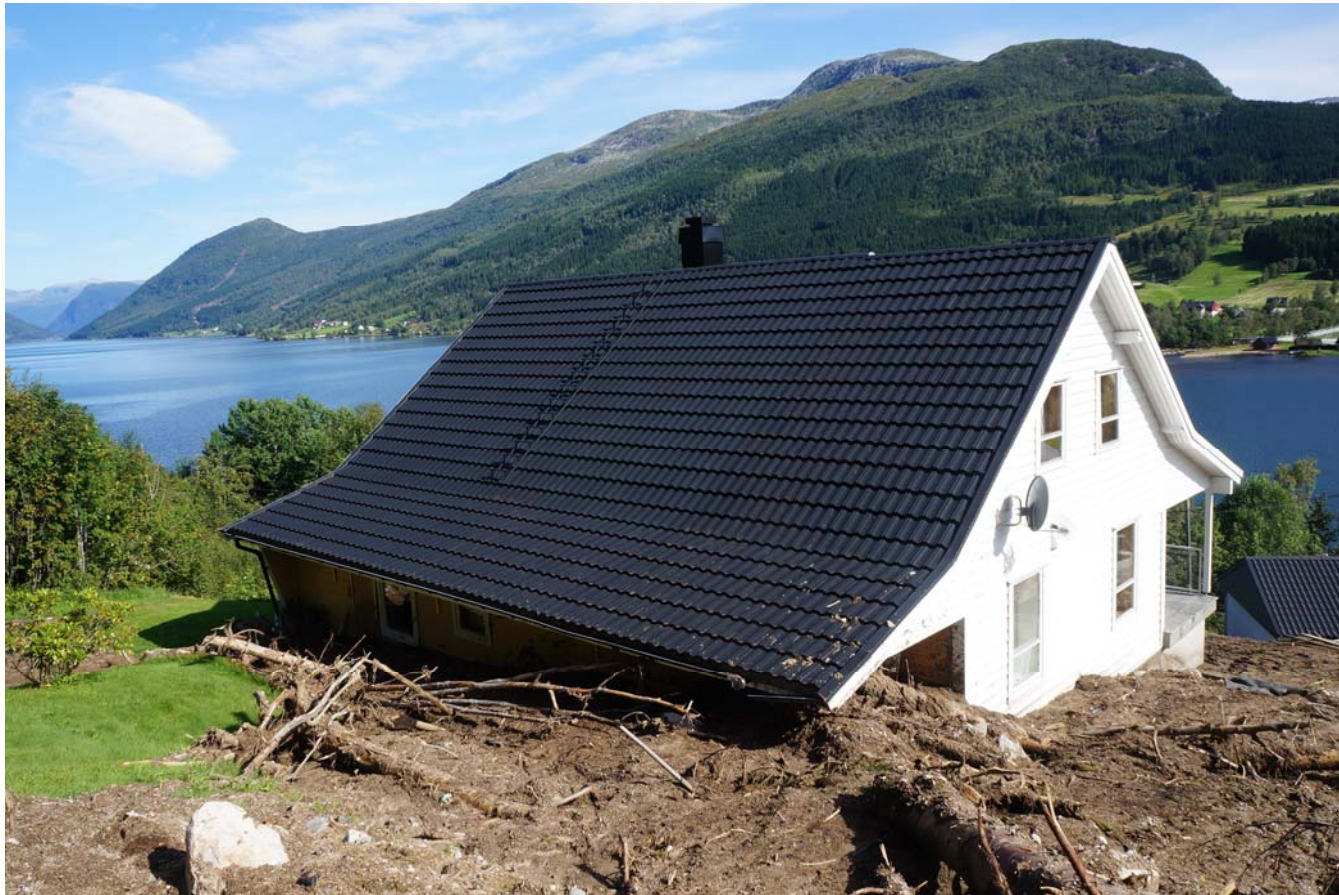
➔ Jølster, 2019 – Vassenden, debris flow along river

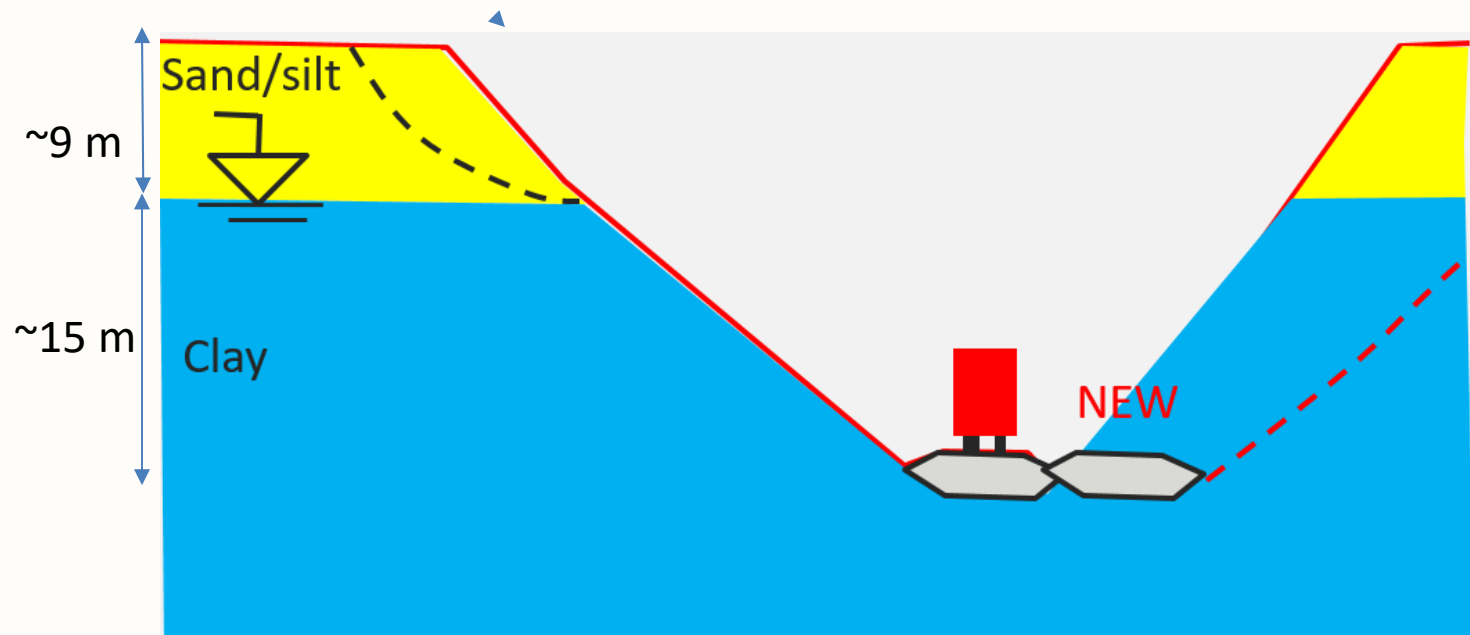
Design criteria for slope stability

- Eurocode 7: $\gamma_m \geq 1.25$ for drained conditions.
- Railway owner requires even higher safety level
- New track activates slope safety requirement for the left slope!
- Preservation of the left slope desirable (cultural heritage)

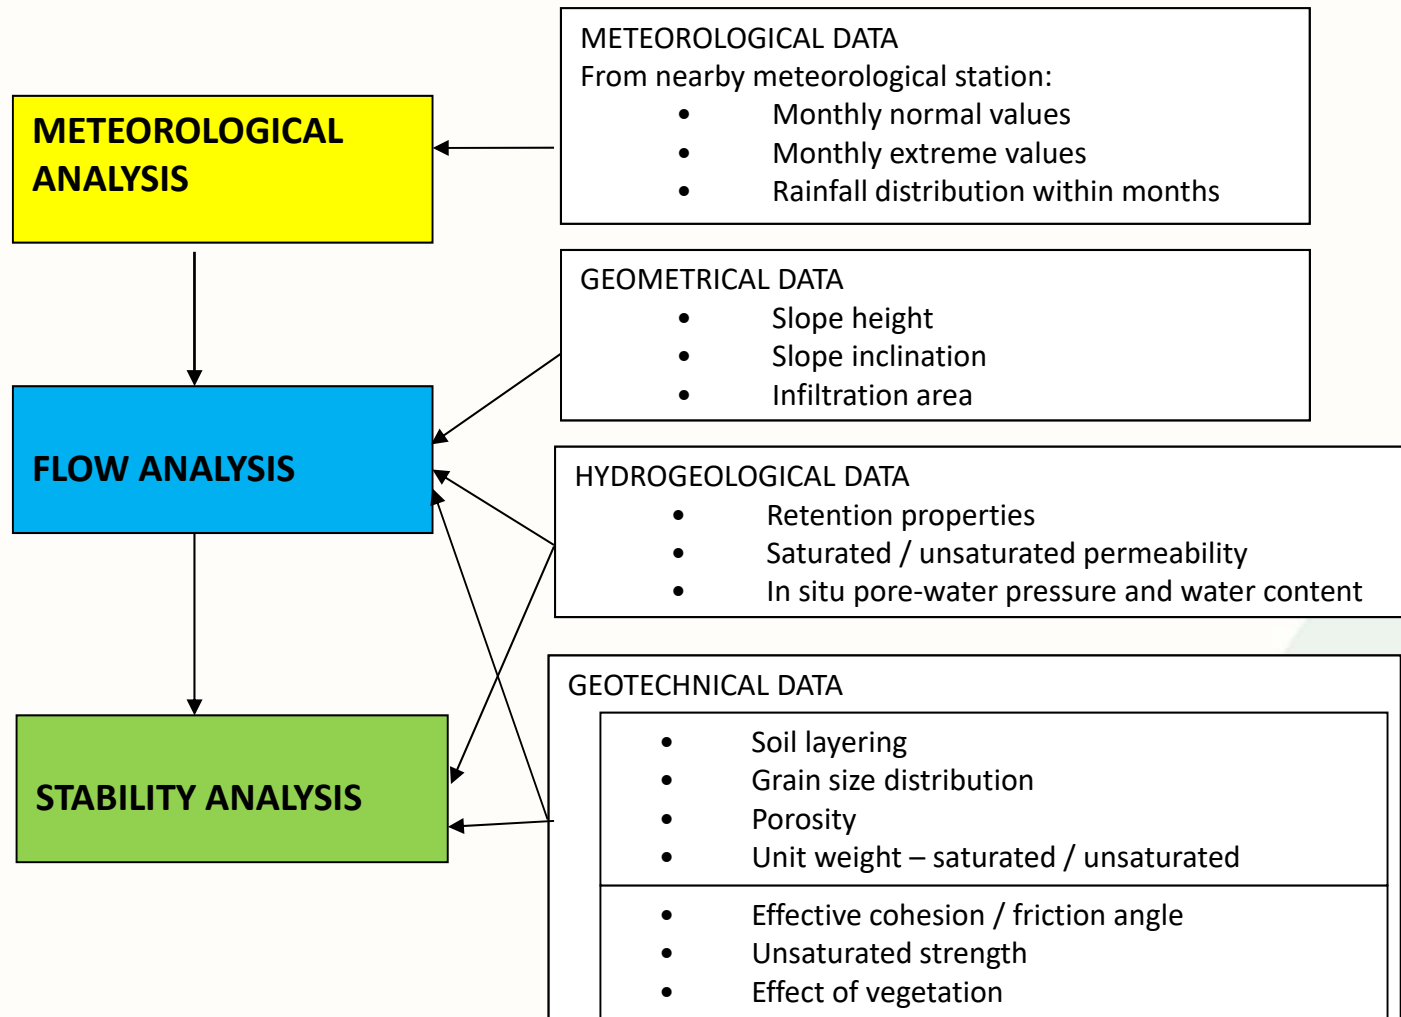
Input required for analysis

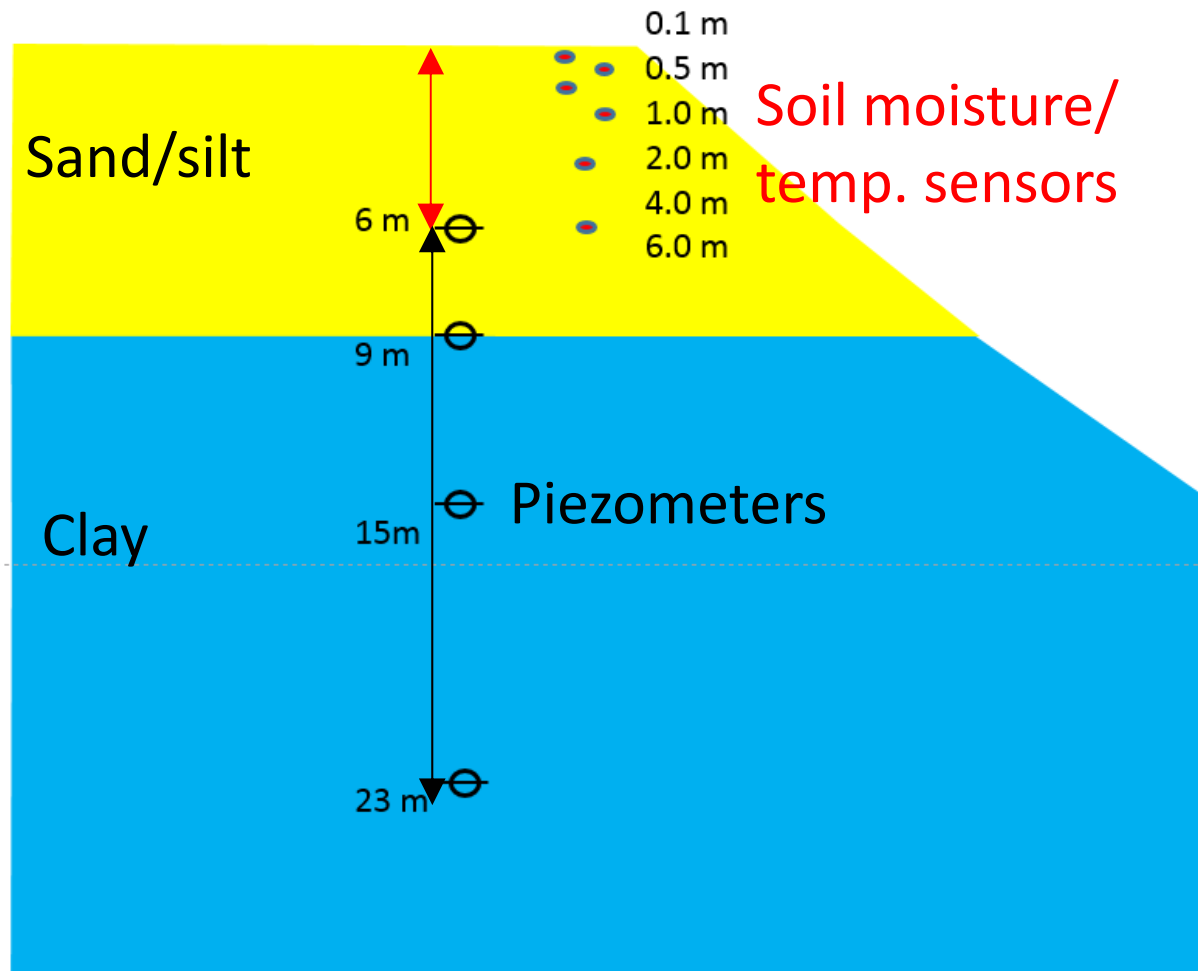
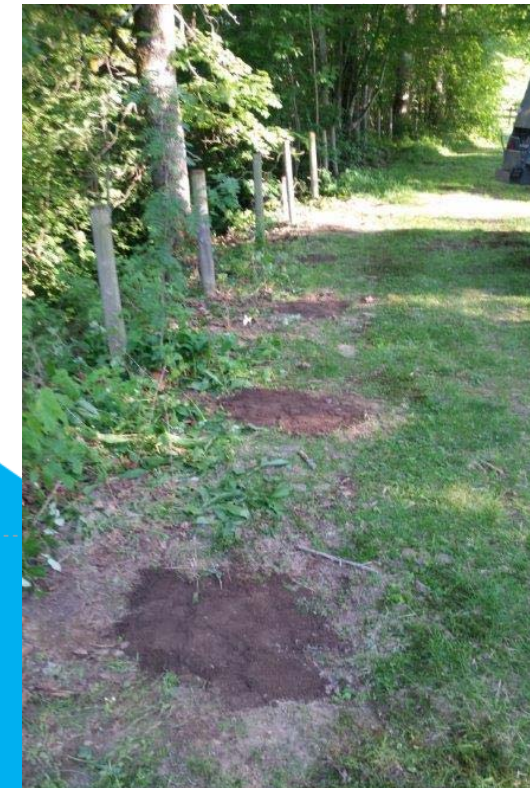
In situ slope instrumentation

Installation holes for sensors

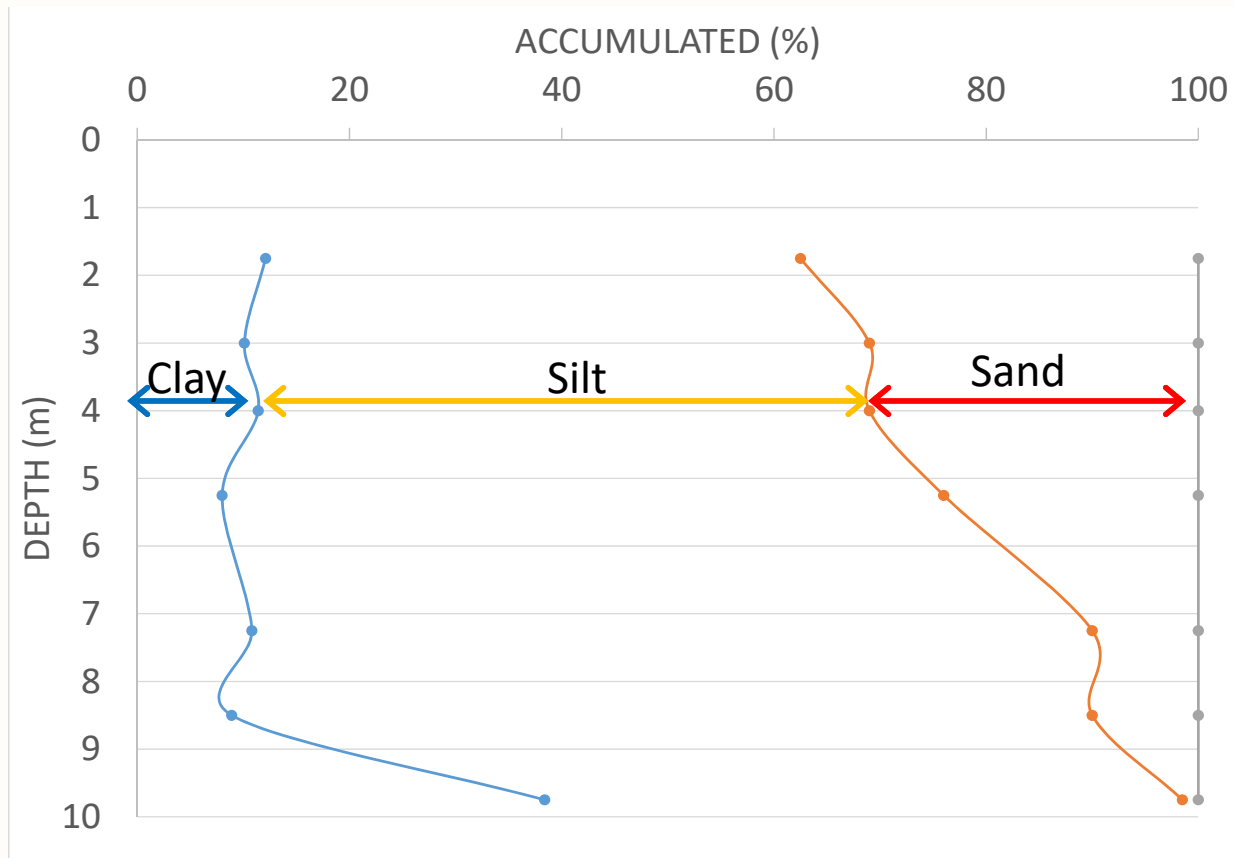
Variation in GSD with depth

Continuous change in grain size distribution. How can we approach this

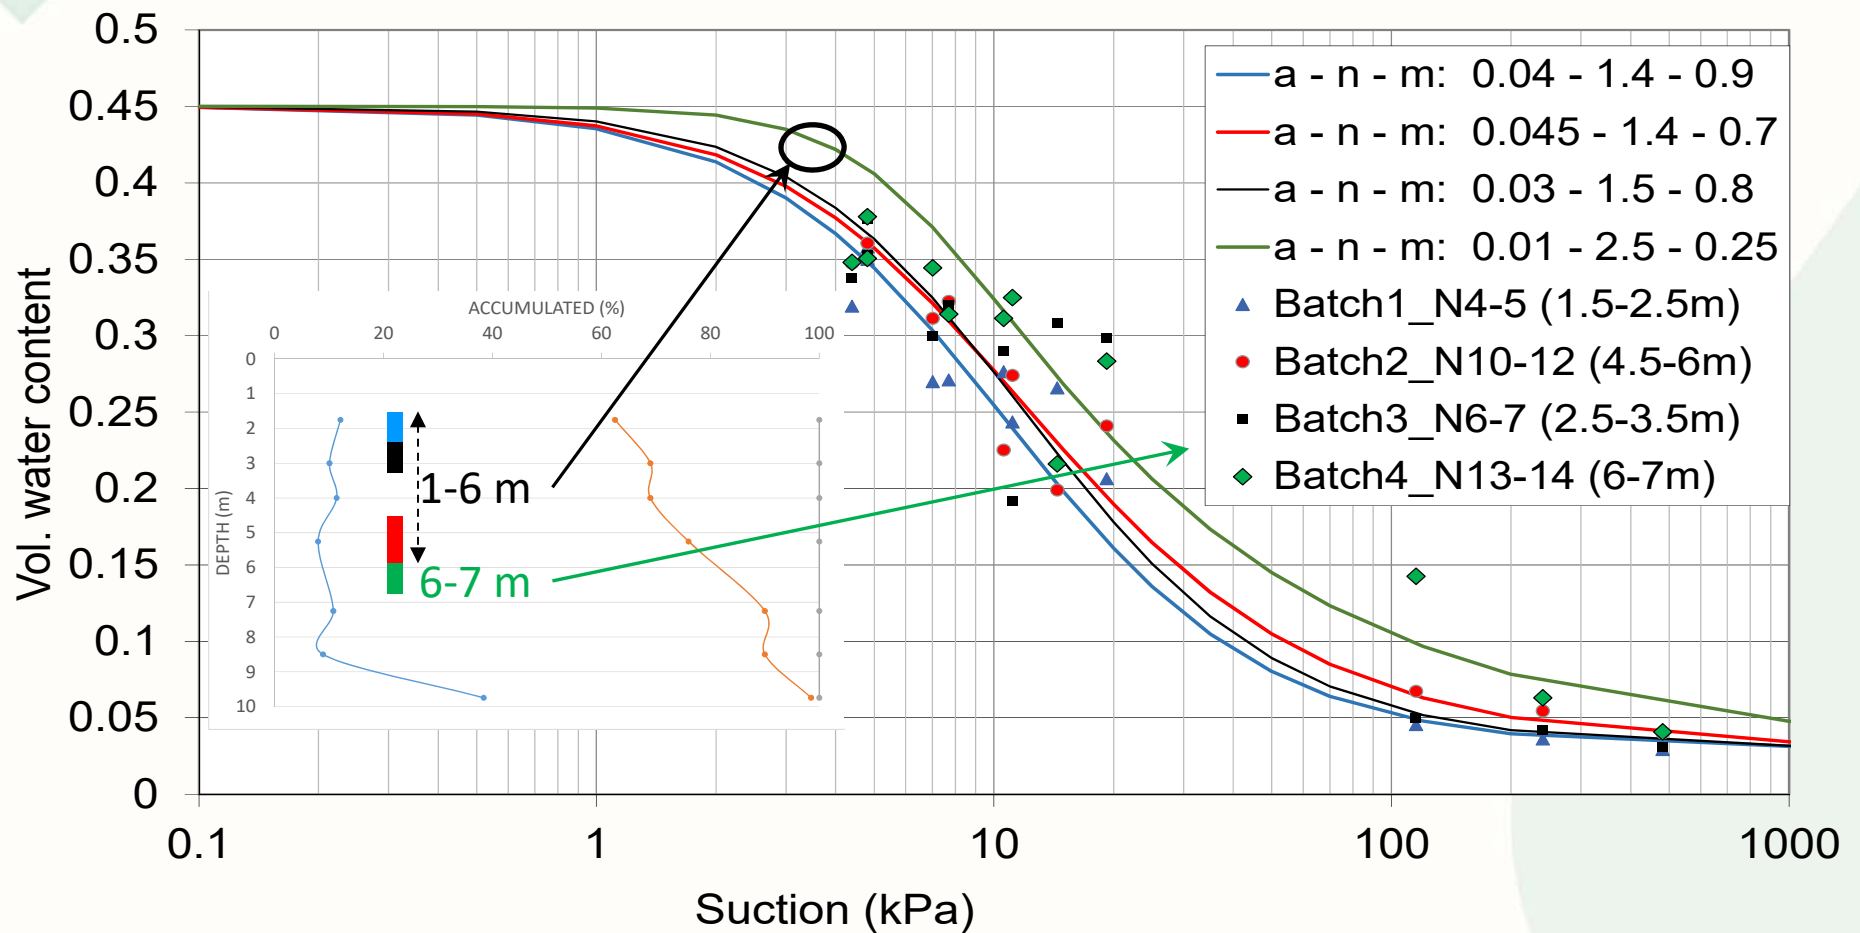
Retention curves and GSD

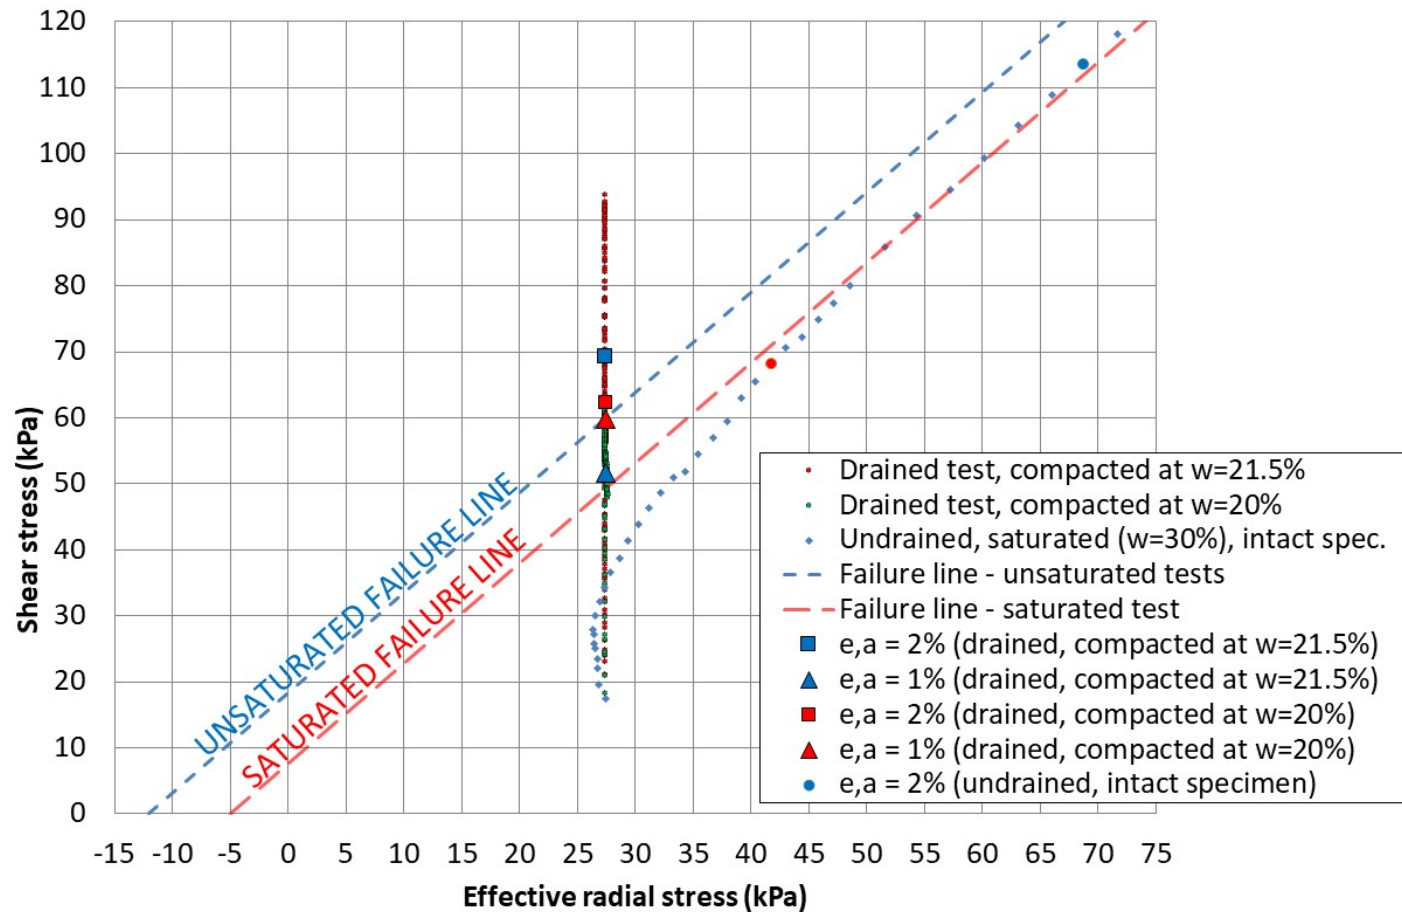
Triaxial tests – intact/compacted (saturated/constant water content)

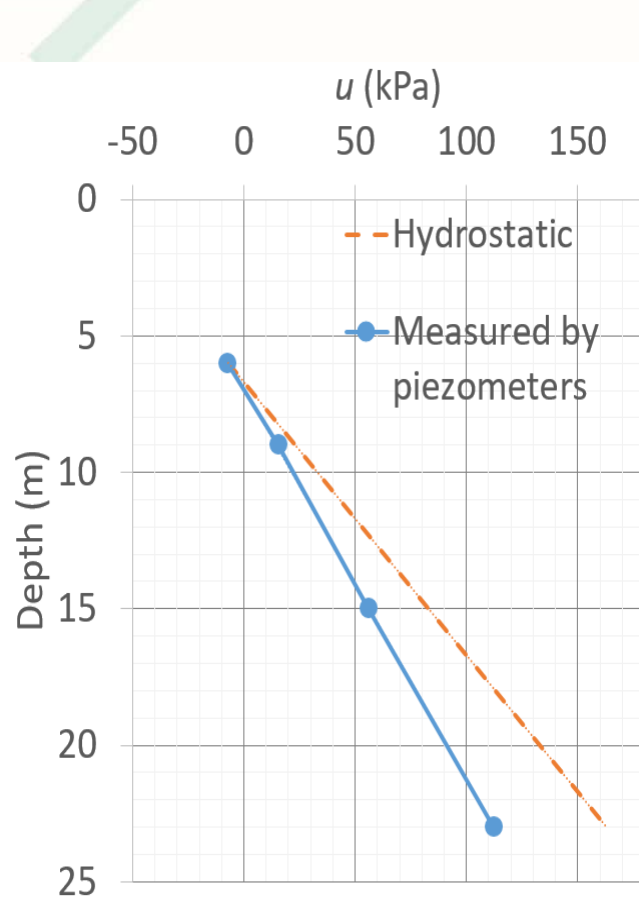
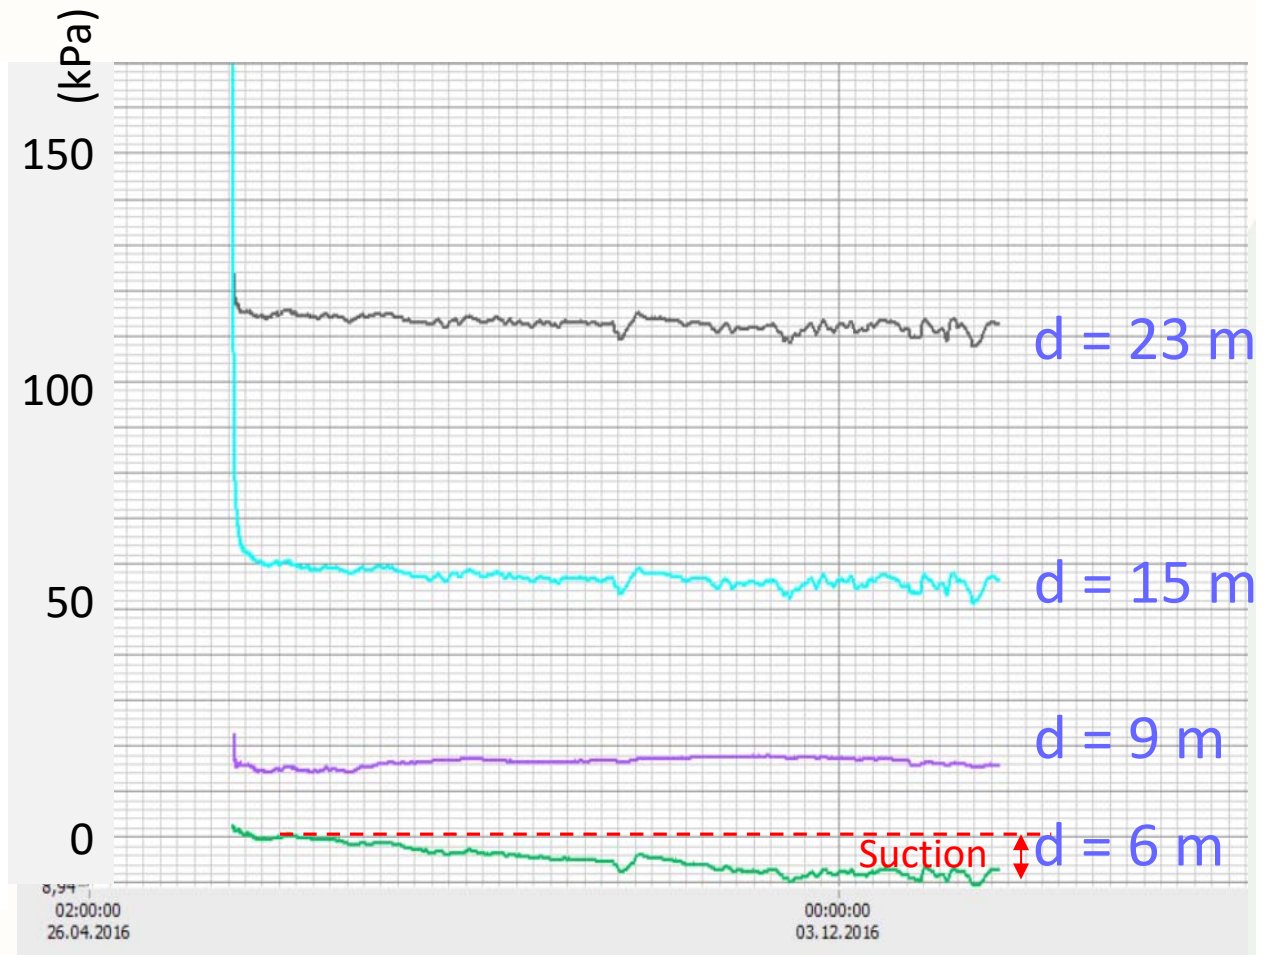
Field data: Pore-water pressure
