MUSLOC 2019, UPC

Landslide activity in Norway due to intense rainfall and snow melt

*Håkon Heyerdahl, José Cepeda, Bjørn
Kalsnes, Kjersti Gislås, Øyvind Høydal,
Frode Sandersen
(NGI / Klima 2050)*

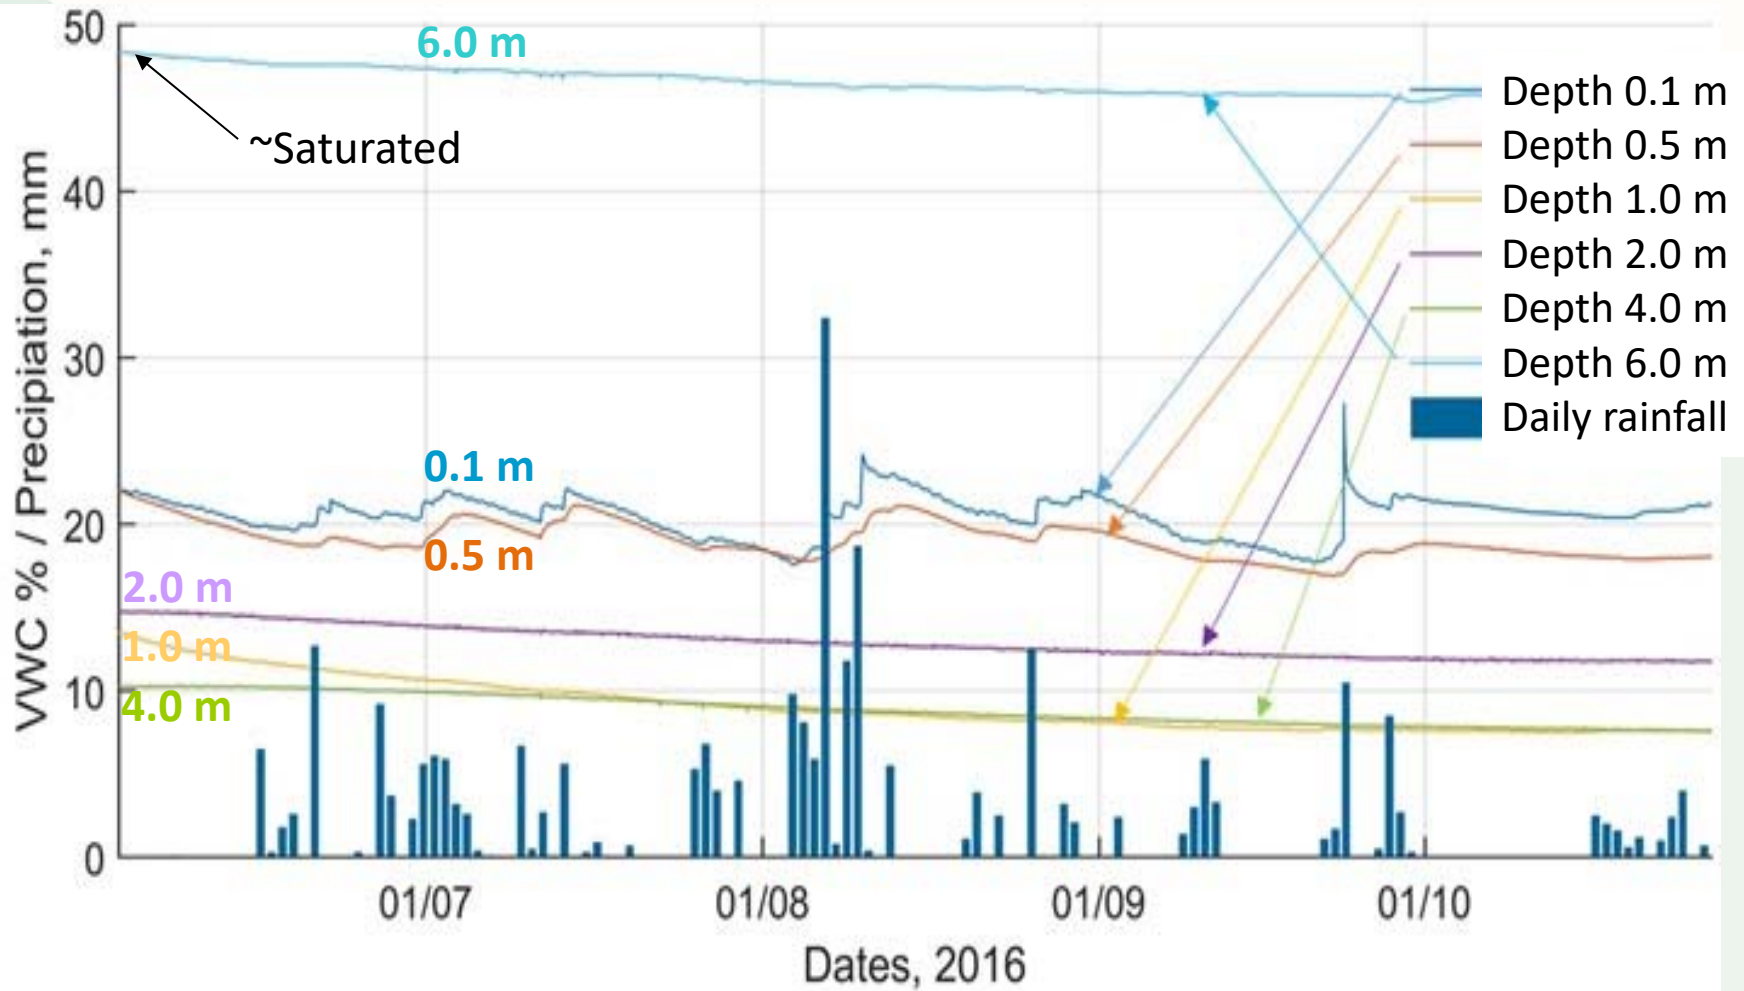
In situ water content and daily rainfall

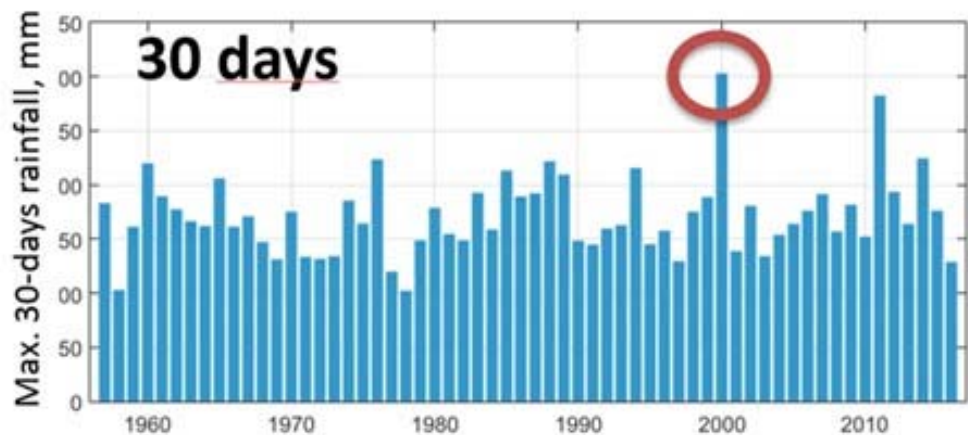
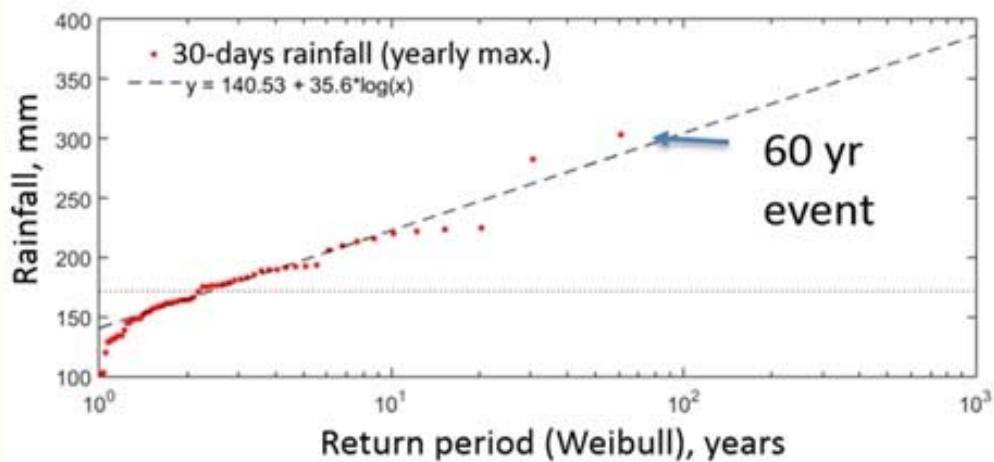
Design rainfall and return period

Date	mm
27-11-2000	303.1
06-09-2011	282.4
03-11-2014	224.6
13-11-1976	223.5
11-09-1988	221.8
27-07-1960	219.9
12-09-1994	215.6
05-09-1985	213.2
25-08-1989	209.6

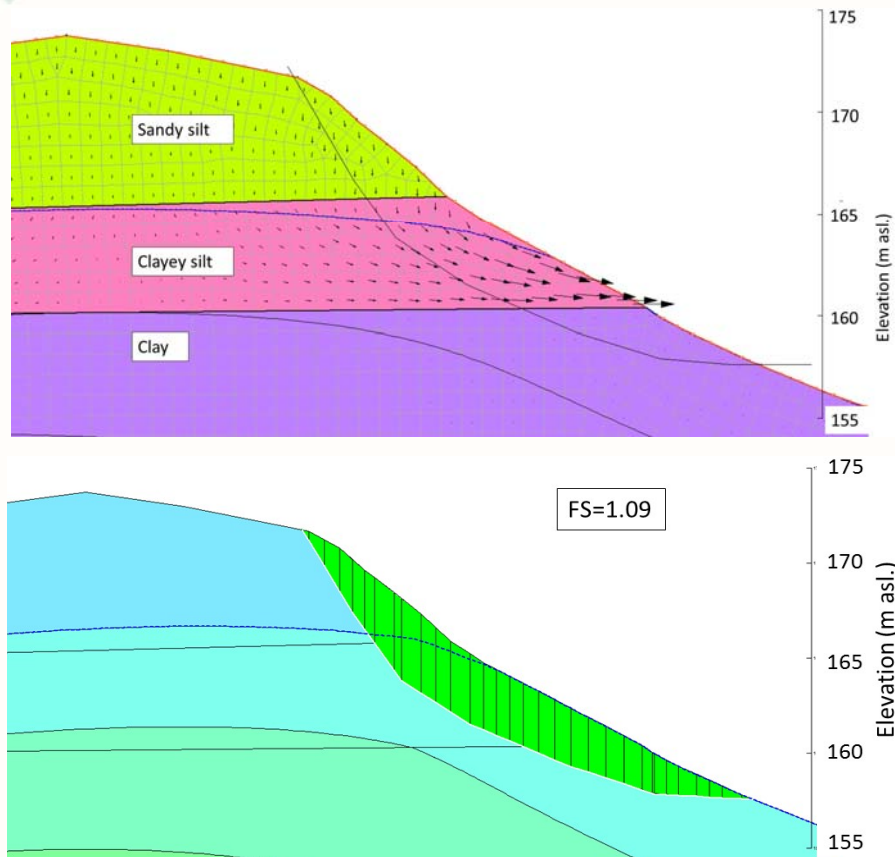
Stability during autumn of year 2000

Day no.	Safety factor (same surface)
0 (1 Aug)	1,09
73 (12 Oct)	1,05
115 (24 Nov)	0,96
134 (14 Dec)	0,97

Note: No failure in year 2000!

- Combined in situ instrumentation, laboratory testing and numerical analyses gave increased understanding of slope respons.
- Stabilizing measures in the upper part of the slope were avoided, assuming $P(\text{failure}) < 1/100$ pr. year is acceptable.
- Review of evaluations to be continued in future pilot study
