# DESSIN

Lunsjpresentasjon for KLIMA 2050, 2016-05-30

# Task 32 Hoffselva demo site (Oslo, Norway)

# T32.2 HRF demonstration plant in Hoffselva

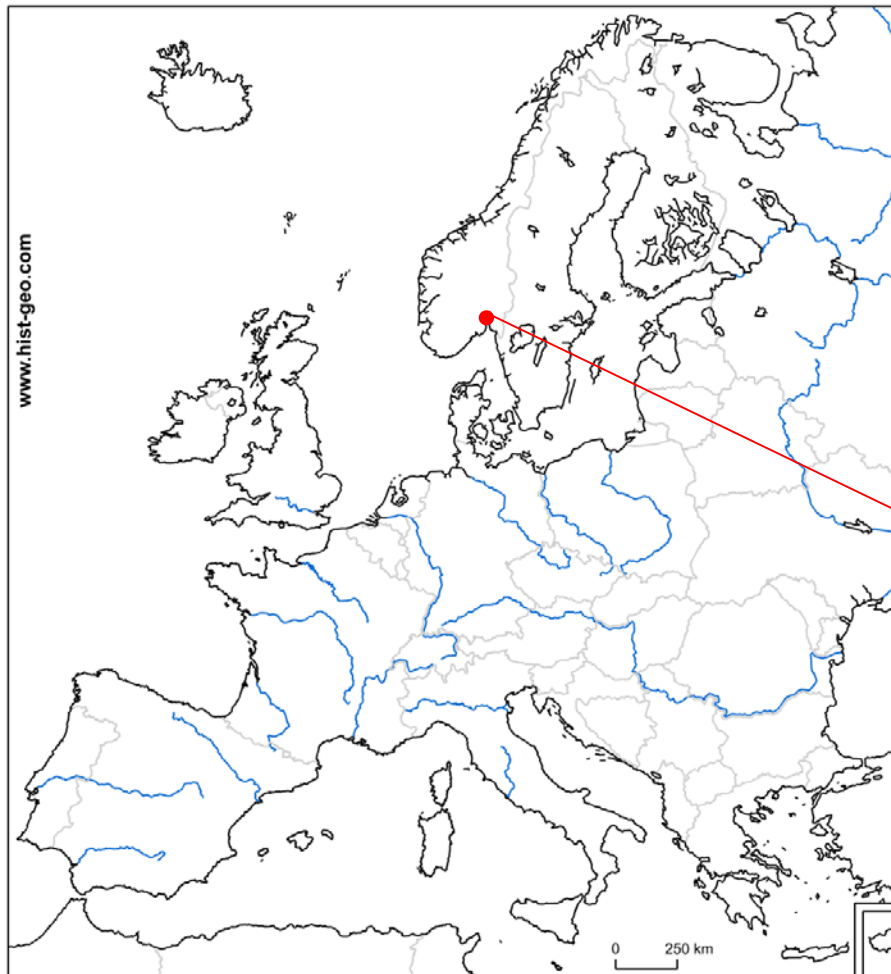
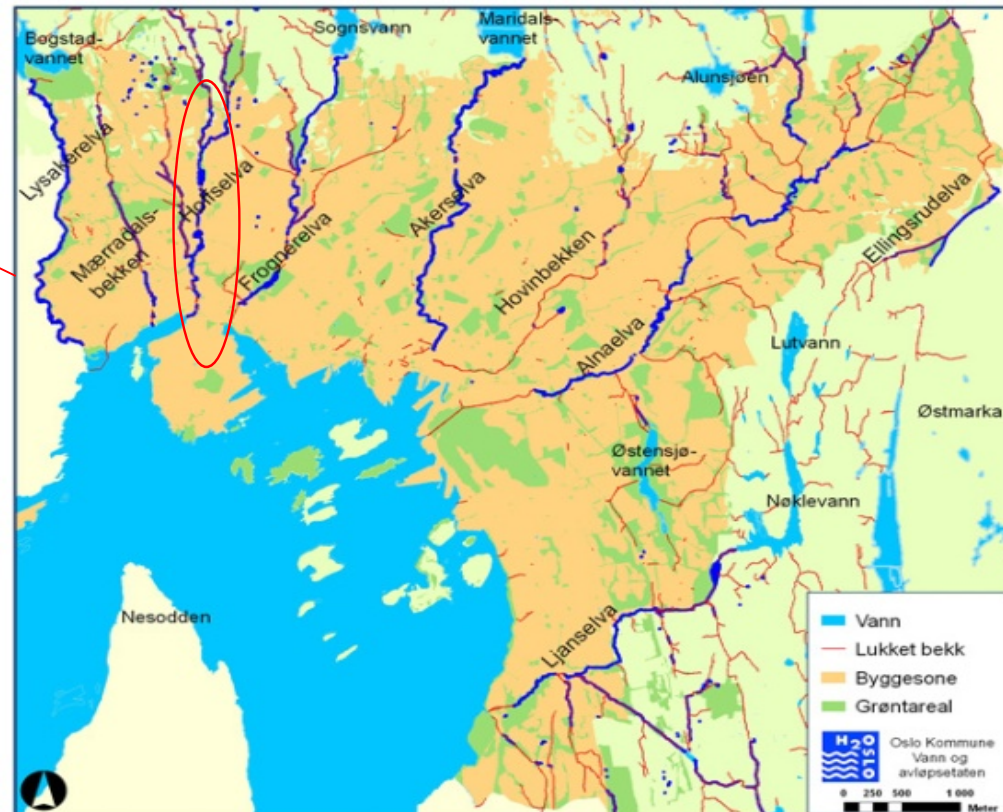
- Catchment area: 1 427 ha
- Number of people connected to the sewer system: 25 500
- There are 22 CSO's discharging into the river
- Aprox. 14 km sewer system

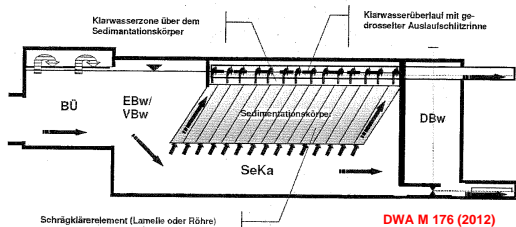
*Local CSO overflow treatment with cross-flow lamella settler*

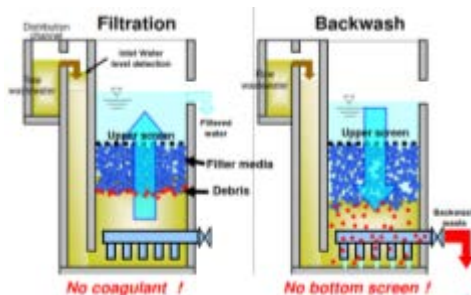
*Local CSO overflow treatment with high rate filter*

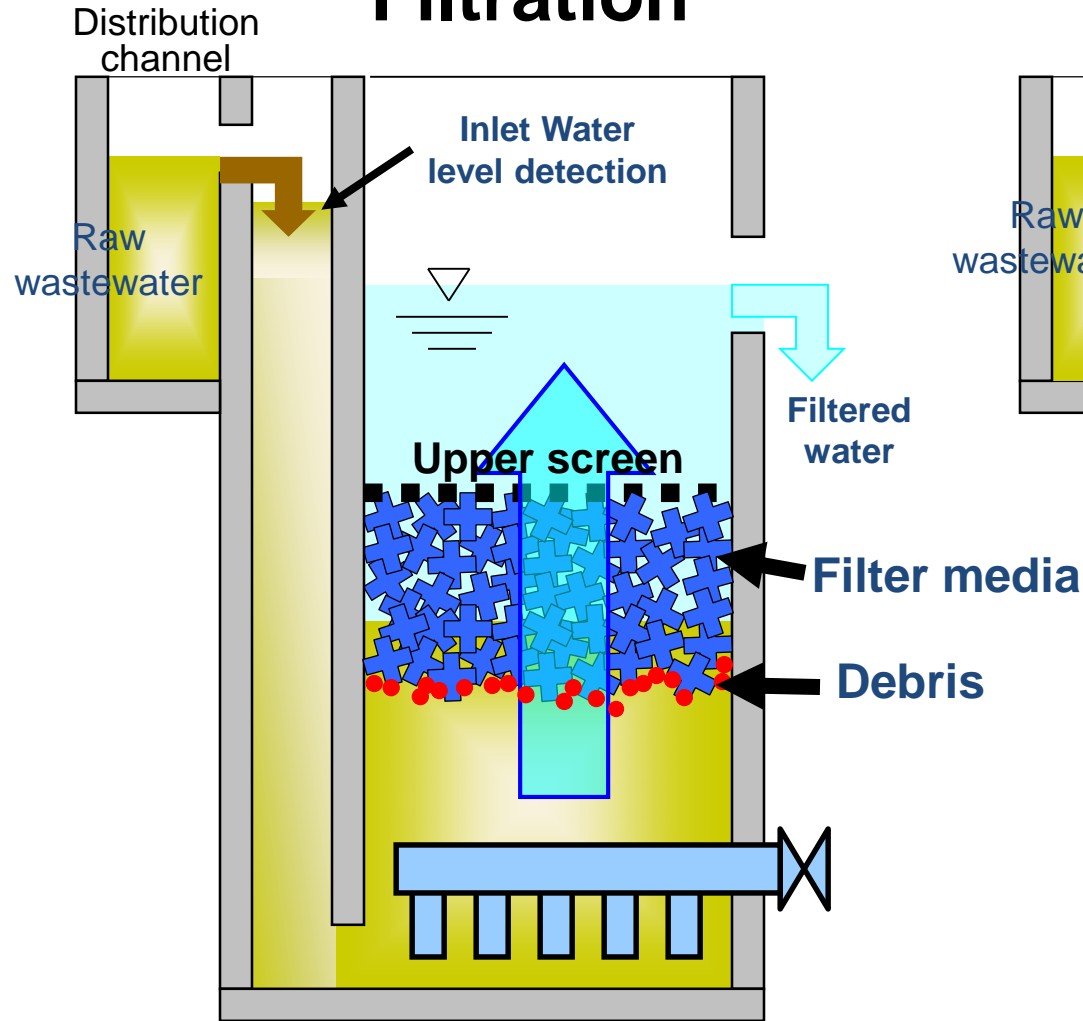
## Filtration

**No coagulant !**

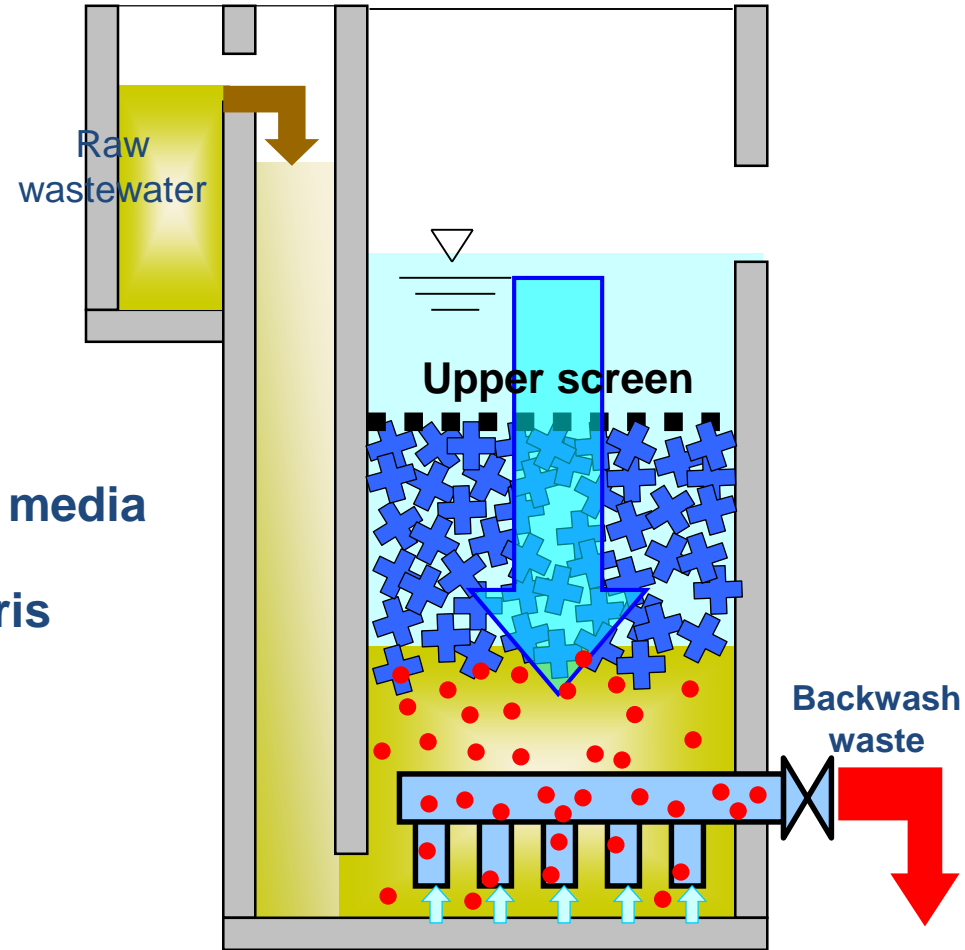
## Backwash

**No bottom screen !**

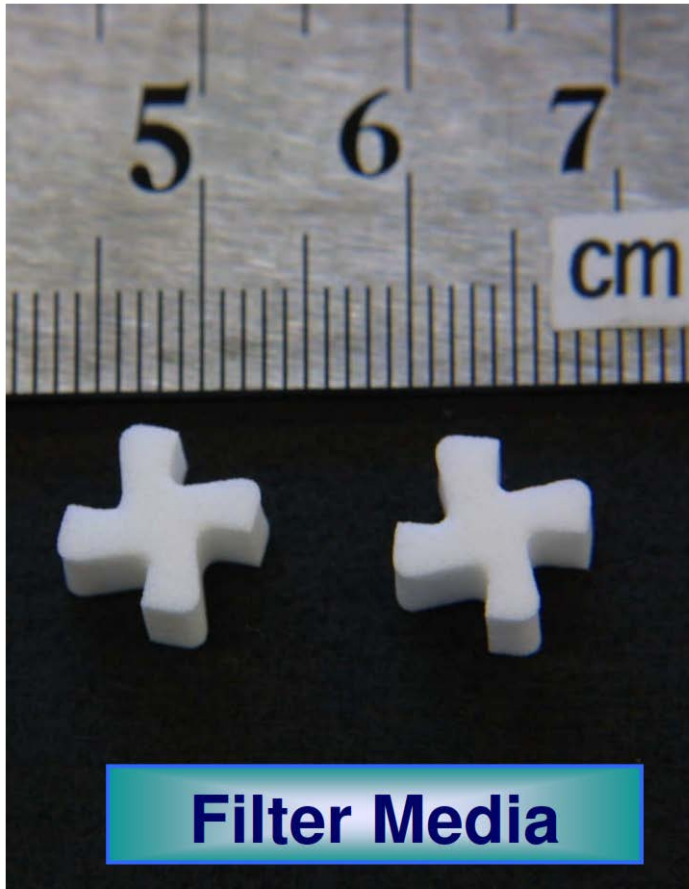
- Floating filter media
- Optimal shape to capture debris, BOD & SS (high void ratio)
- Acid – proof, Alkali - proof

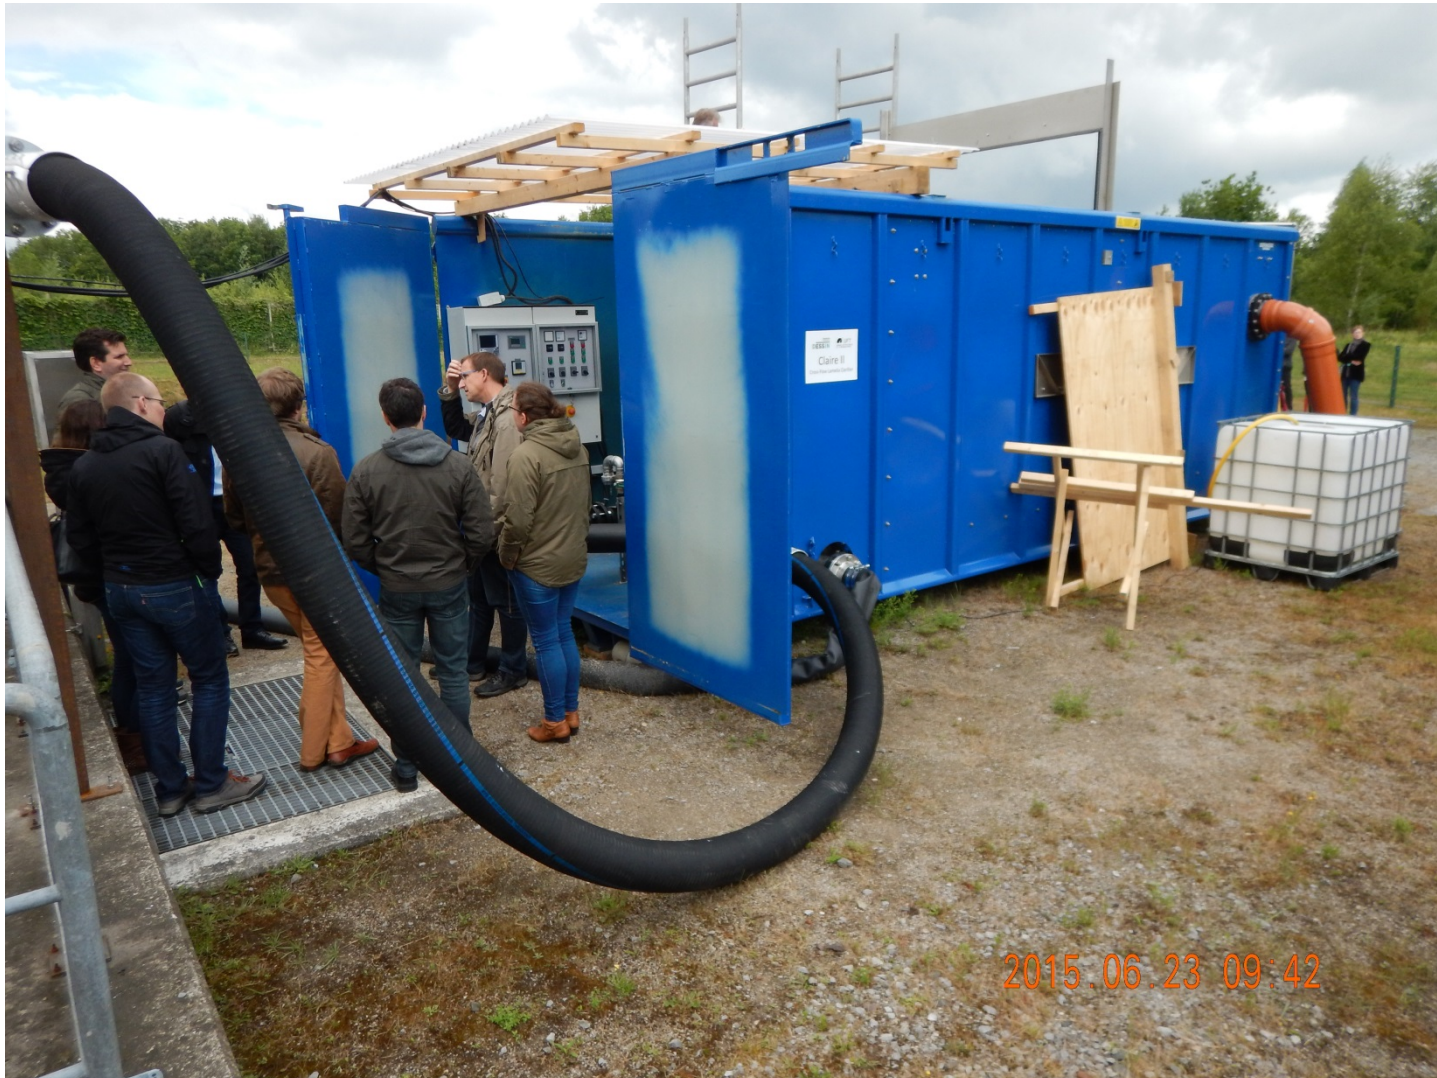
- **UFT demonstration plant for lamella sedimentation at Emscher in Germany**

- Well known e.g. from mineral industries
- **New application: Stormwater treatment in combined or separate sewer systems**
- Some pilot plants → positive results

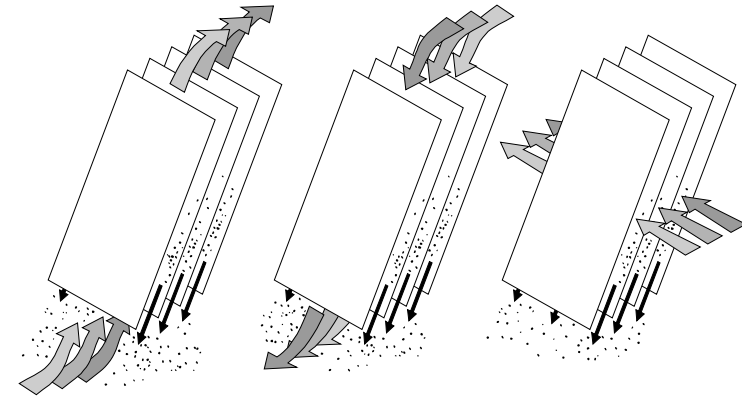
## Types of lamella separators

Upflow Downflow Cross-current

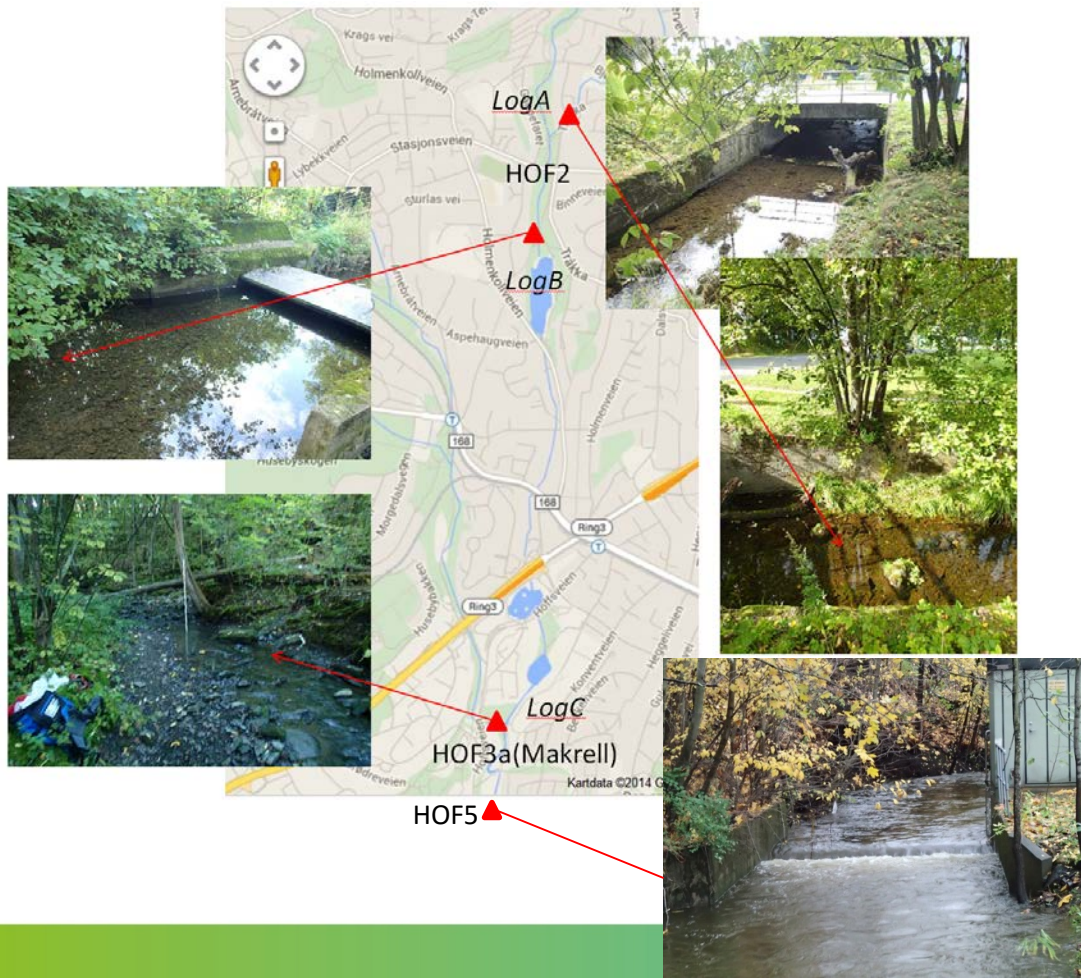
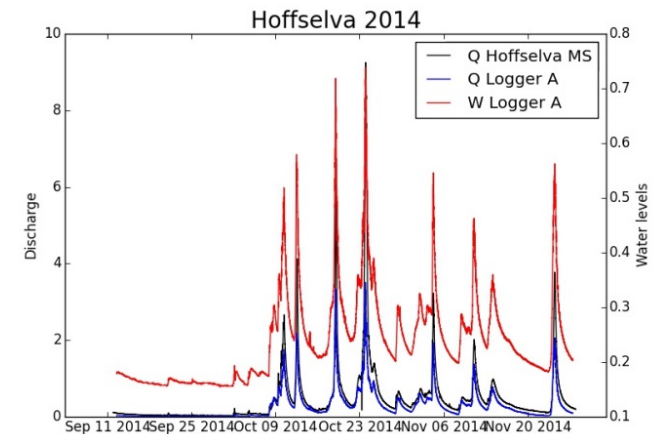
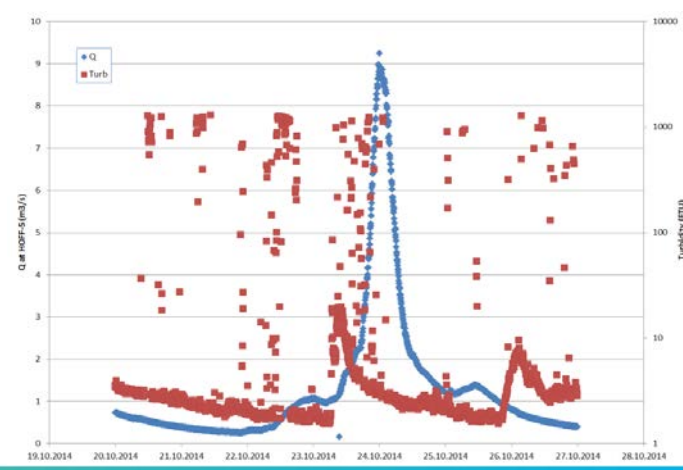
# T32.4 Monitoring water quality in Hoffselva and evaluation of solutions

- Three temporary water level loggers operated Autumn 2014 and 2015 (LogA, LogB, LogC)
- One turbidity logger + discharge logger operated Autumn 2014 and 2015, and water sampling and analysis in collaboration with NIVA (HOF5)

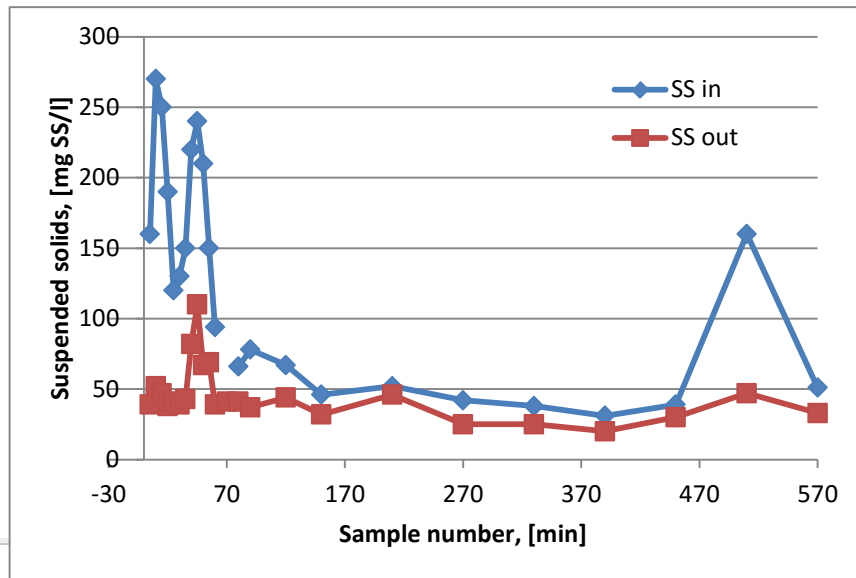
Comparison of on-line turbidity and SS from water samples, CSO event 17th Nov. 2015
